ANALYSIS OF BASE PARAMETER DATA AND EROSION INVENTORY DATA FOR SEDIMENT TMDL DEVELOPMENT WITHIN THE BOULDER-ELKHORN TPA

Montana Department of Environmental Quality
Water Quality Planning Bureau
P.O. Box 200901
Helena, MT 59620-0901

Water & Environmental Technologies, PC
480 East Park Street, #200
Butte, MT 59701

January 2011

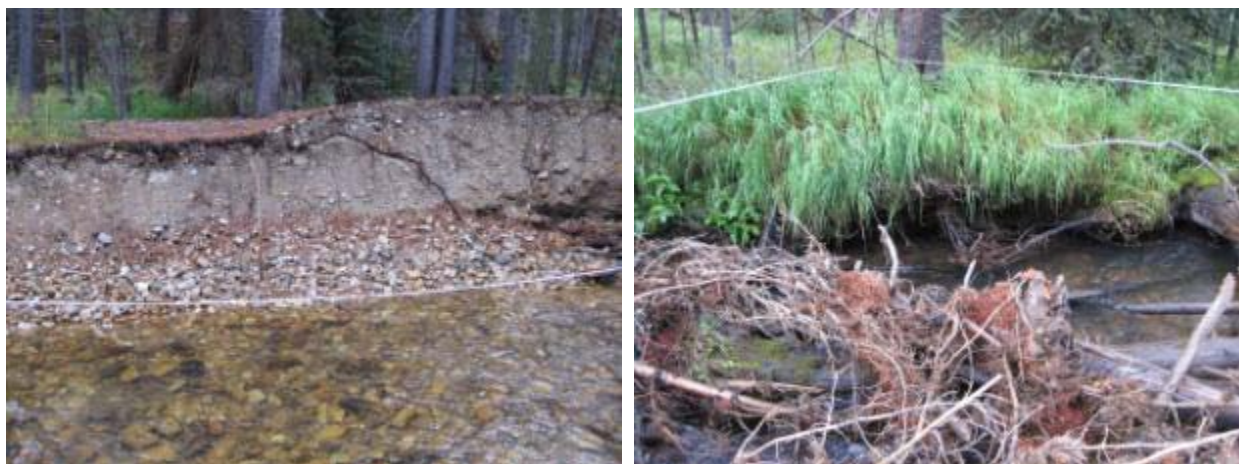
Figure 4-1. Typical eroding streambank conditions in Basin Creek Reach 08-02.

Only three eroding banks were identified in this reach, including two actively eroding banks and one slowly eroding bank. Banks are typically armored with cobbles and large gravel. The stream channel is overwidened through this reach. Typical eroding streambank conditions are depicted for this reach in **Figure 4-1** and sediment loading results are provided in **Table 4-5**.

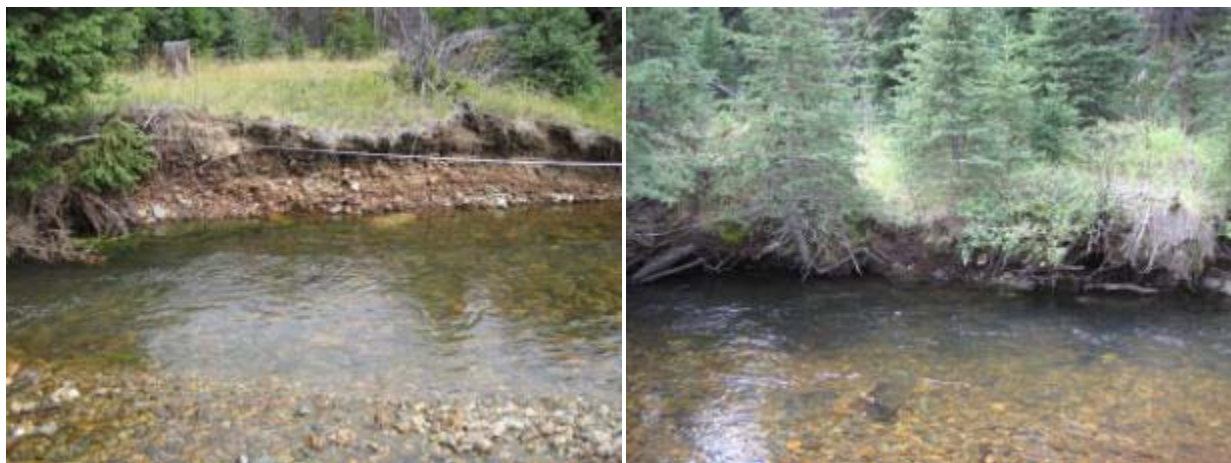
Figure 4-2. Typical eroding streambank conditions in Basin Creek Reach 15-02.

This reach had seven eroding banks, including four actively eroding and three slowly eroding. Actively eroding banks were typically associated with meander bends that direct flow into the bank and have limited stabilizing vegetation, possibly as a result of prior logging activity. Slowly eroding banks were accompanied by dense mature vegetation on the banks, including established willow and fir trees. Typical eroding streambank conditions are depicted in **Figure 4-2** and sediment loading results are provided in **Table 4-5**.

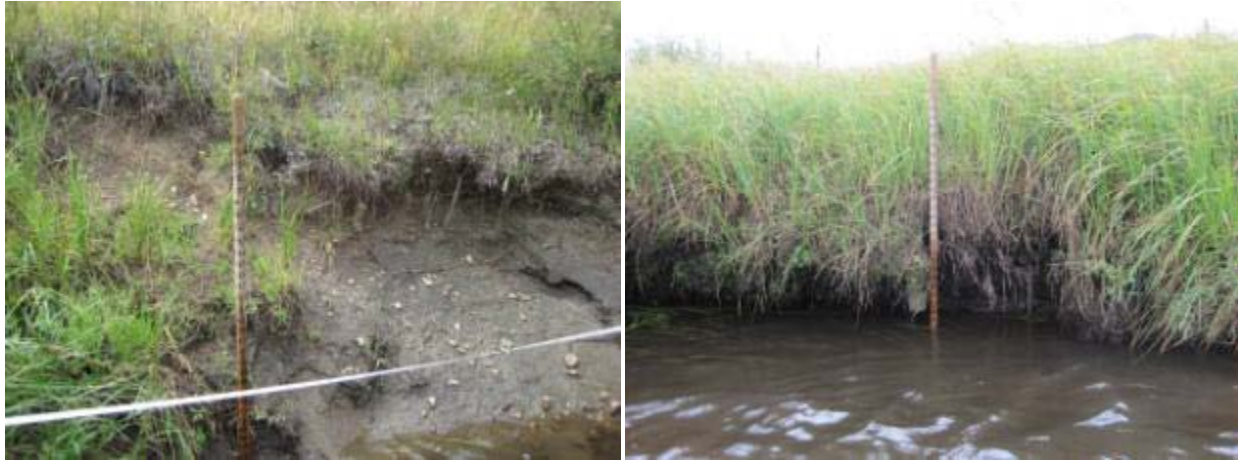
Figure 4-3. Typical eroding streambank conditions in Bison Creek Reach 04-02.

overhanging but well vegetated. Typical eroding streambank conditions are depicted for this reach in **Figure 4-3** and sediment loading results are provided in **Table 4-6**.

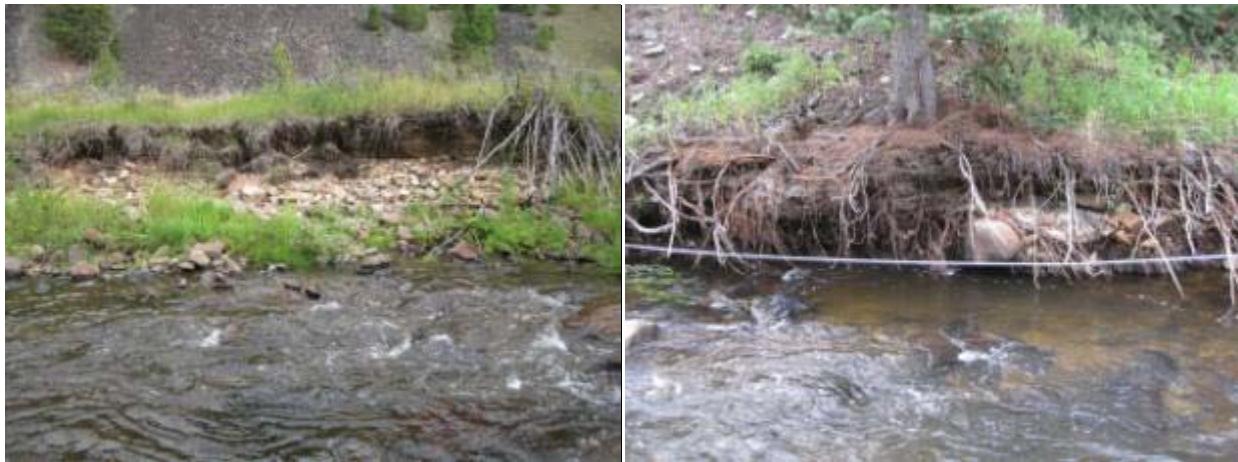
Figure 4-4. Typical eroding streambank conditions in Bison Creek Reach 11-01.

This reach had one slowly eroding bank and seven actively eroding banks. Actively eroding banks are typically tall and located on meander bends with little stabilizing vegetation and large cobble substrate armoring the toe. Slowly eroding banks are overhanging but bound by roots of mature vegetation. Typical eroding streambank conditions are depicted for this reach in **Figure 4-4** and sediment loading results are provided in **Table 4-6**.

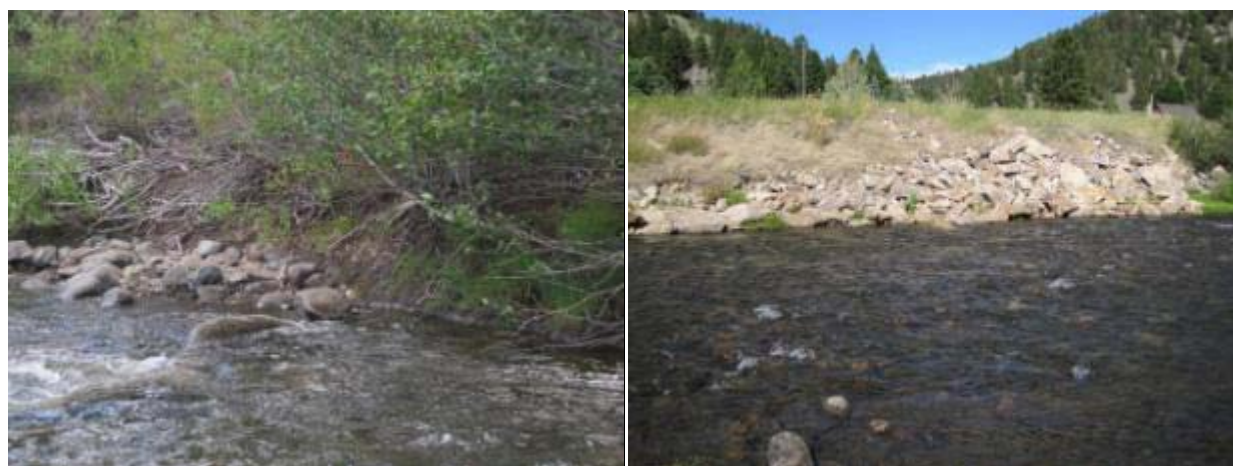
Figure 4-5. Typical eroding streambank conditions in Boulder River Reach 12-04.

This reach has only two slowly eroding banks, mainly because the channel is armored with rip-rap and large cobbles to protect the neighboring roads. One eroding bank occurs where the stream hits an area of road fill, and the other contains hard packed clay and is bound by mature alders and rushes. Typical eroding streambank conditions are depicted for this reach in **Figure 4-5** and sediment loading results are provided in **Table 4-7**. The left photo shows an example of a slowly eroding bank within this reach, and the right photo shows an example of the rip-rap stabilization within this reach.

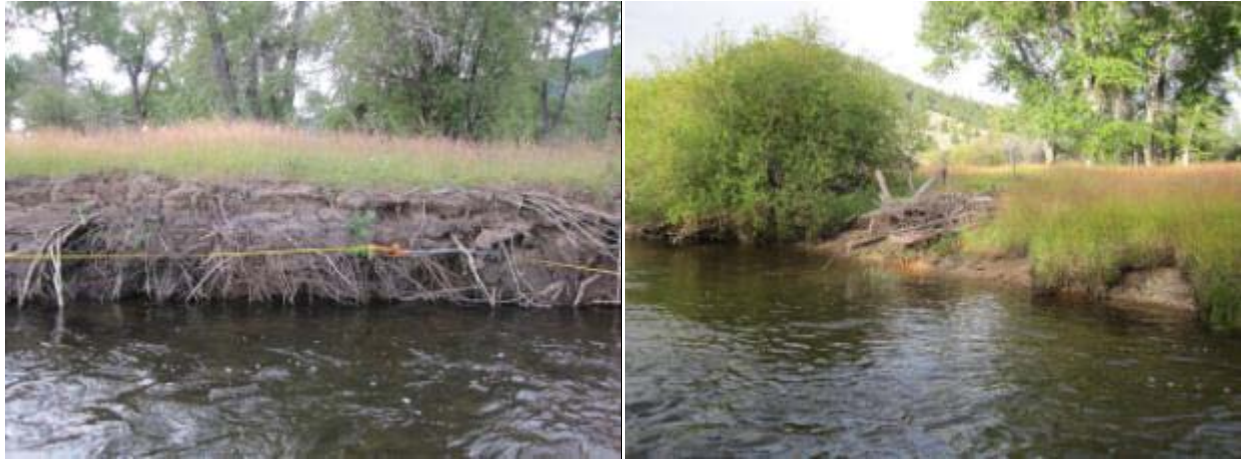
Figure 4-6. Typical eroding streambank conditions in Boulder River Reach 13-04.

sometimes with poorly placed rip-rap material that has slumped into the stream channel. Slowly eroding banks were low angled and had some vegetative cover. Typical eroding streambank conditions are depicted for this reach in **Figure 4-6** and sediment loading results are provided in **Table 4-7**.

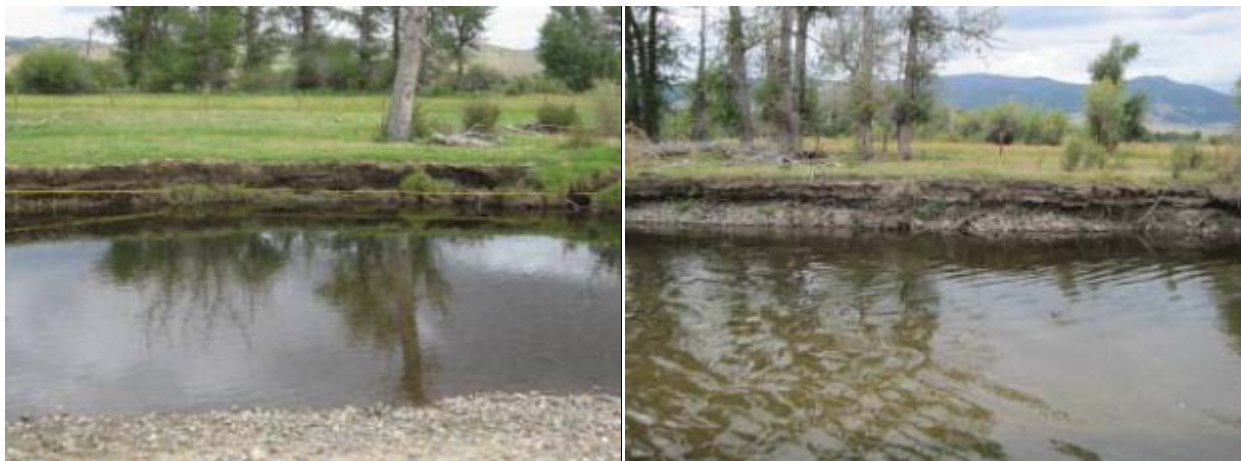
Figure 4-7. Typical eroding streambank conditions in Boulder River Reach 13-10.

Reach BLDR 13-10 has thirteen actively eroding banks that typically occur along outside meander bends. Eroding banks are near vertical and have either a silty/clayey substrate that is slumping into the stream channel, or they have a cobble layer near the toe that provides some armoring against erosion. Typical eroding streambank conditions are depicted for this reach in **Figure 4-7** and sediment loading results are provided in **Table 4-7**.

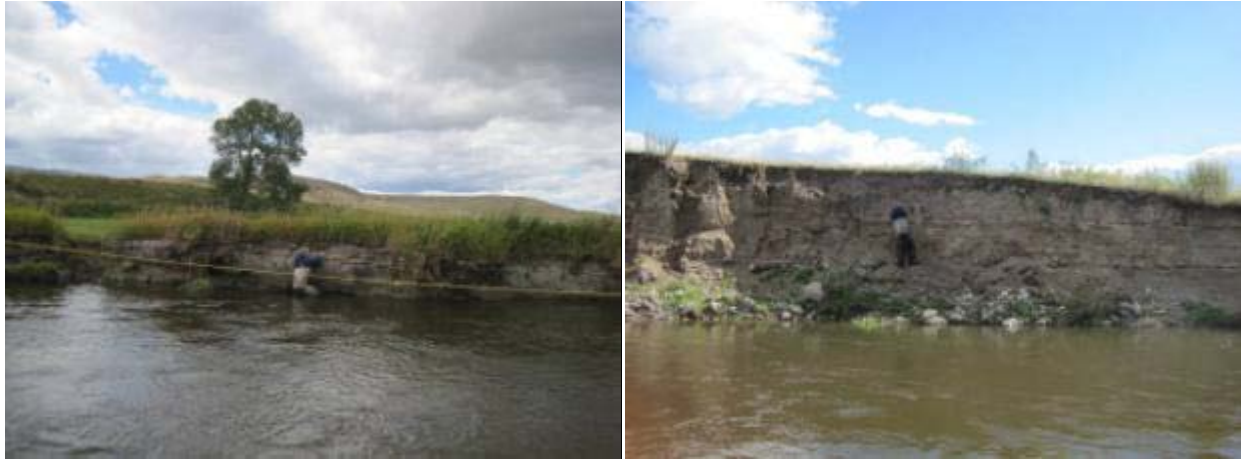
Figure 4-8. Typical eroding streambank conditions in Boulder River Reach 13-23.

(14.5'). One slowly eroding bank was identified, which had substantial willow growth that helps stabilize the bank. This reach had the highest loading rate of all sampled reaches. Typical eroding streambank conditions are depicted for this reach in **Figure 4-8** and sediment loading results are provided in **Table 4-7**.

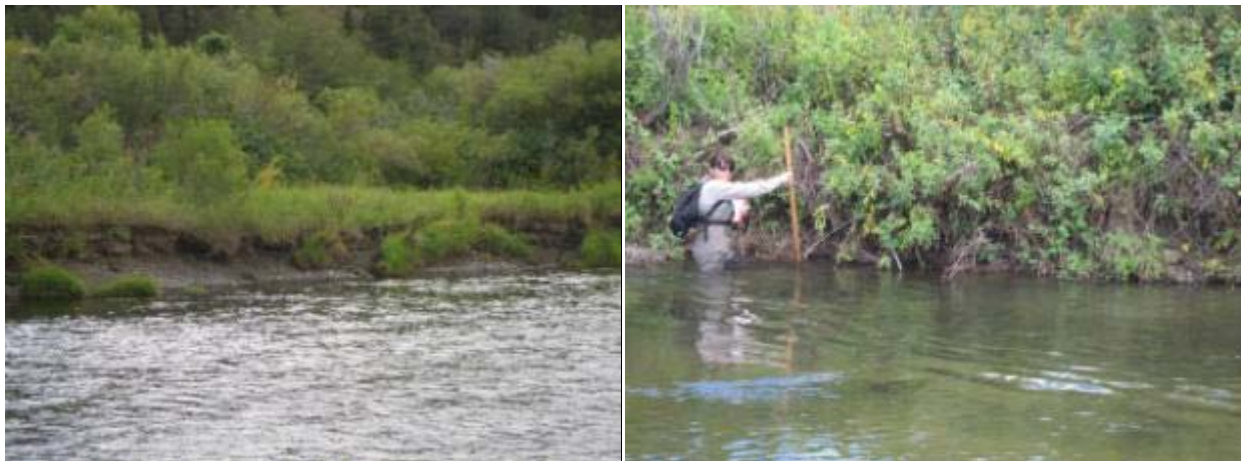
Figure 4-9. Typical eroding streambank conditions in Boulder River Reach 13-33.

This reach has twelve actively eroding banks and three slowly eroding banks. Actively eroding banks were typically slumping banks that occur on outside meander bends with little surface protection. One tall (11') actively eroding bank occurs where the stream closely parallels the road. The slowly eroding banks occur on straight sections where vegetation is established and root density is higher. Typical eroding streambank conditions are depicted for this reach in **Figure 4-9** and sediment loading results are provided in **Table 4-7**.

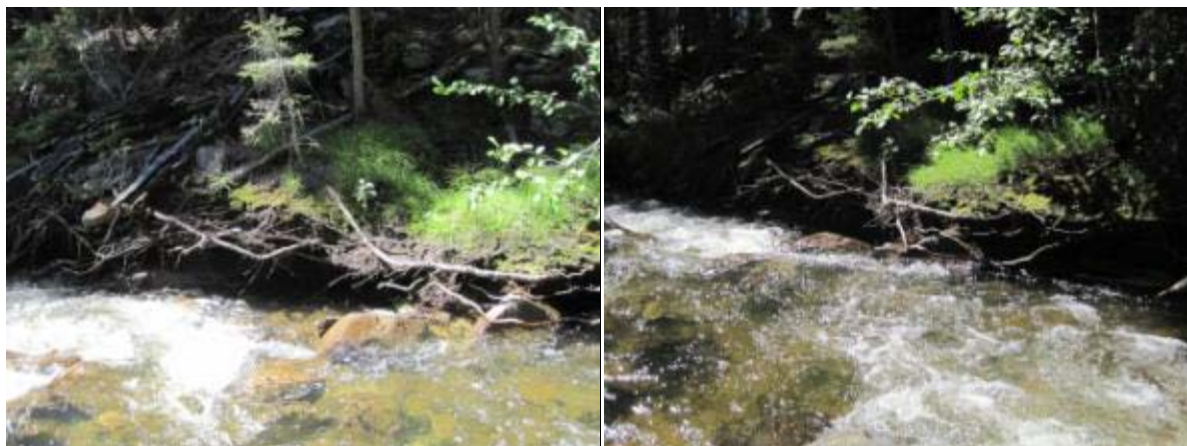
Figure 4-10. Typical eroding streambank conditions in Cataract Creek Reach 18-01.

Only one eroding streambank was identified in this reach, which was a slowly eroding undercut bank. Most banks in this high gradient reach are composed of hard packed clay and are armored with binding root masses and overgrown moss. Typical eroding streambank conditions are depicted in **Figure 4-10** and sediment loading results are provided in **Table 4-8**.

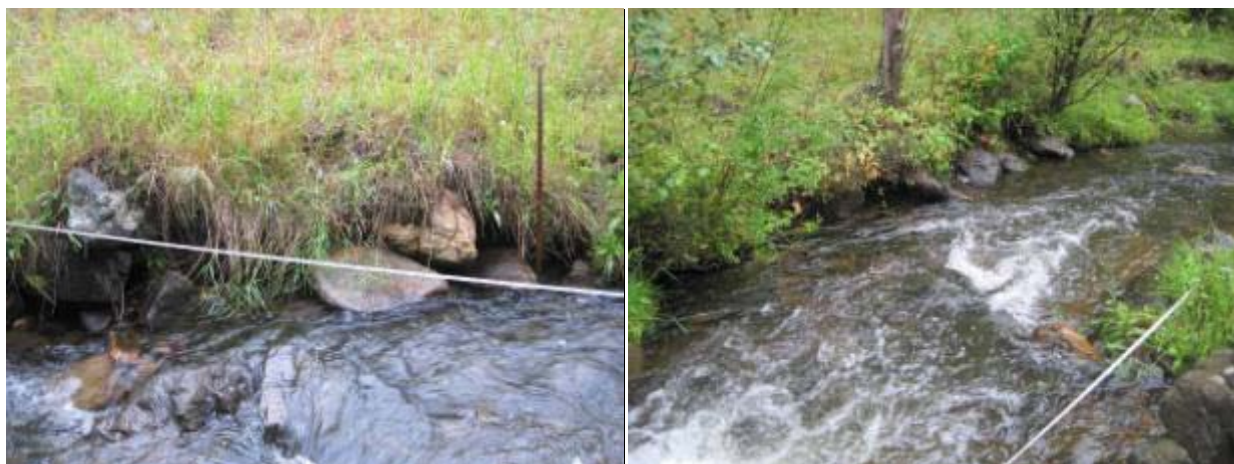
Figure 4-11. Typical eroding streambank conditions in Elkhorn Creek Reach 23-01.

Seven slowly eroding banks were identified in reach ELKH 23-01. Eroding banks were typically short in length, well vegetated, and occur at knick points coming from boulders, LWD, or tight stream meanders. In several places, the erosion is influenced by reduction of vegetation and bank trampling from hoof shear. Typical eroding streambank conditions are depicted in **Figure 4-11** and sediment loading results are provided in **Table 4-9**.

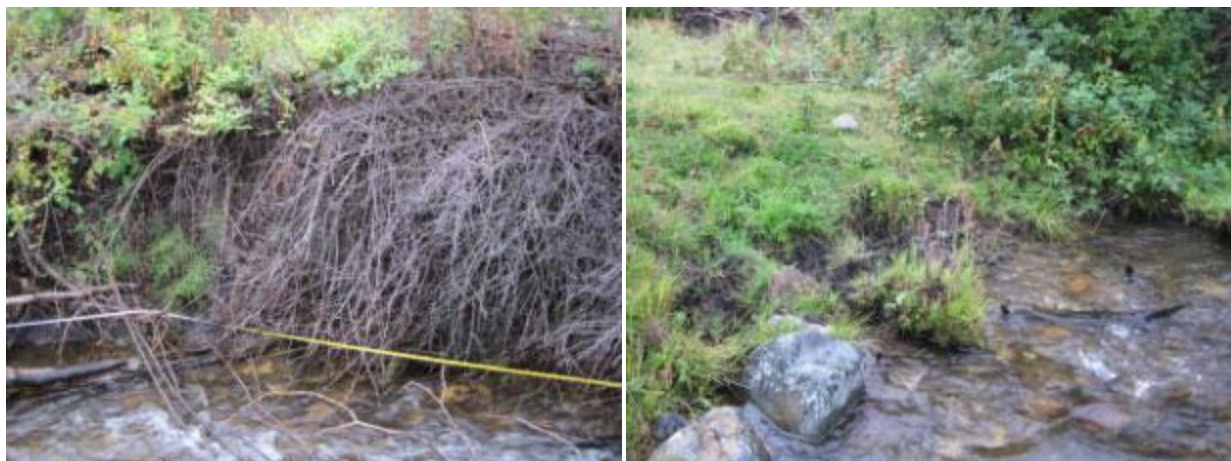
Figure 4-12. Typical eroding streambank conditions in Elkhorn Creek Reach 28-01.

This reach had thirteen actively eroding banks with three primary bank types. Eroding banks included tall, steep banks that are partially protected by dead woody vegetation, low angle banks at stream crossings that are trampled by cattle, and a few slumping vegetated banks on outside meander bends. Typical eroding streambank conditions are depicted in **Figure 4-12** and sediment loading results are provided in **Table 4-9**.

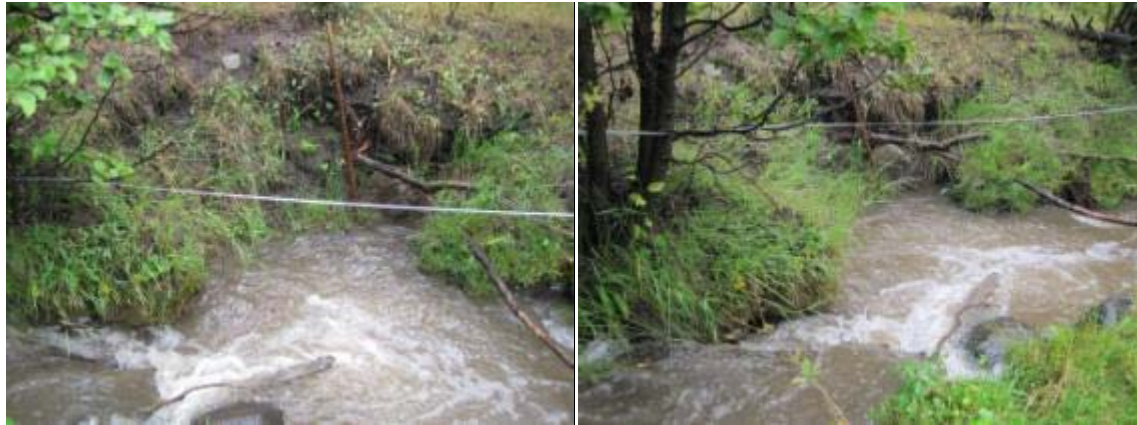
Figure 4-13. Typical eroding streambank conditions in High Ore Creek Reach 09-01.

Only one eroding streambank was identified in this reach, which is a tall, poorly vegetated bank where LWD directs stream flow into the bank. Banks are quite stable despite limited riparian vegetation, possibly because floodplain has been significantly flattened and few tall banks exist. Typical eroding streambank conditions are shown in **Figure 4-13** and sediment loading results are provided in **Table 4-10**.

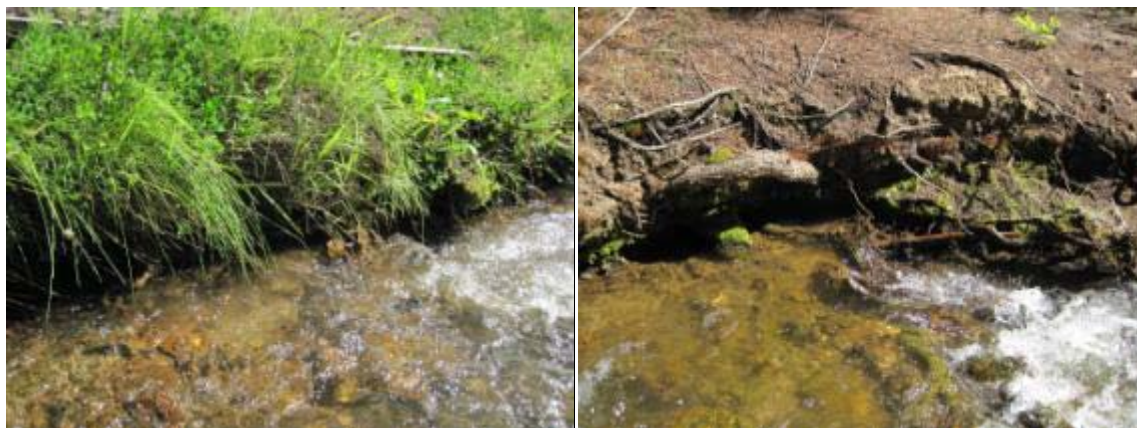
Figure 4-14. Typical eroding streambank conditions in High Ore Creek Reach 15-01.

This reach has six slowly eroding banks and one actively eroding bank. Slowly eroding banks are short, overhanging banks with good riparian vegetation. The actively eroding bank is taller with exposed soil, but bound by roots. Typical eroding streambank conditions are shown in **Figure 4-14** and sediment loading results are provided in **Table 4-10**.

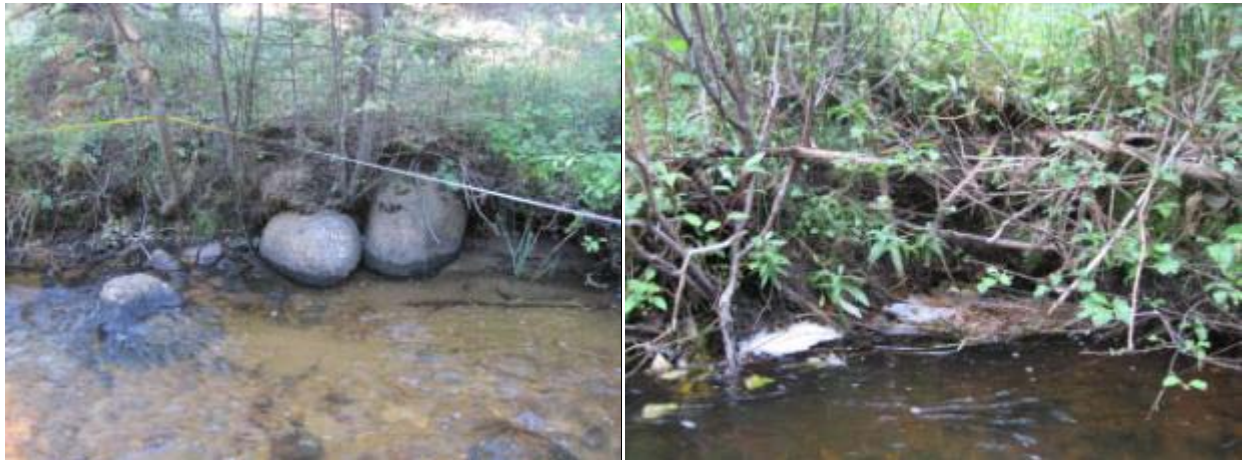
Figure 4-15. Typical eroding streambank conditions in Little Boulder River Reach 32-01.

This site has eleven slowly eroding banks that are typically near vertical with woody vegetation and a dense root mass that helps stabilize the banks. Undercut banks are not uncommon, especially in areas where stream is altered by large boulders or stabilized by mature coniferous trees. Typical eroding streambank conditions are depicted in **Figure 4-15** and sediment loading results are provided in **Table 4-11**.

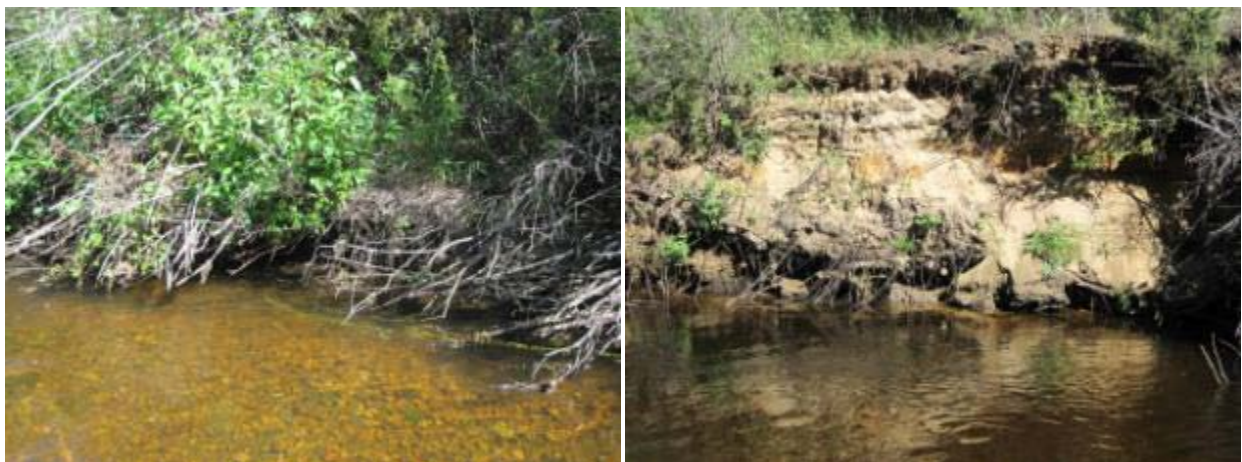
Figure 4-16. Typical eroding streambank conditions in Little Boulder River Reach 37-01.

This reach has ten eroding streambanks, including two actively eroding and eight slowly eroding. Slowly eroding banks are typically found on outside bends, but have significant surface protection from dead and living willows. One actively eroding bank occurs where the stream abuts a tall sandy terrace. Typical eroding streambank conditions are depicted in **Figure 4-16** and sediment loading results are provided in **Table 4-11**.

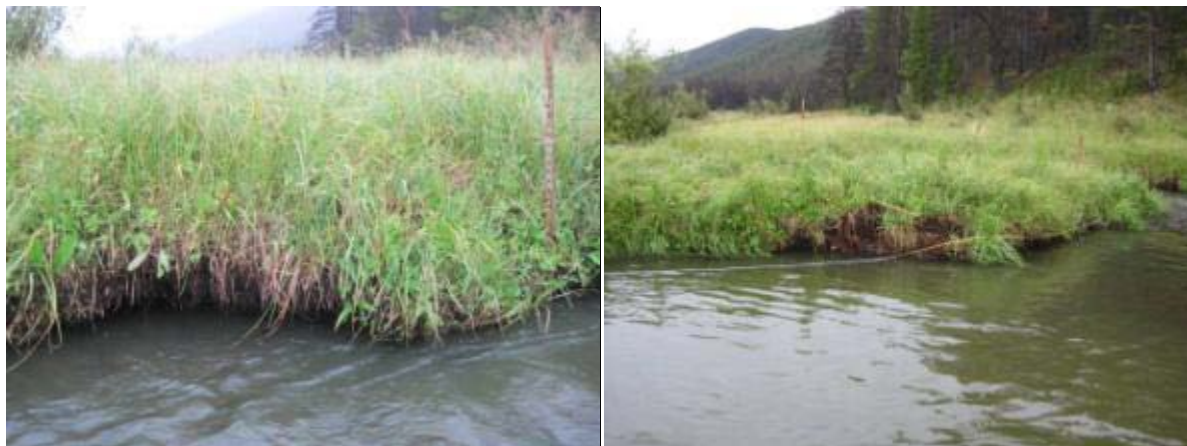
Figure 4-17. Typical eroding streambank conditions in Lowland Creek Reach 08-01.

Fourteen slowly eroding streambanks were identified in this reach. Banks are typically well vegetated with sedges and grasses, but are often undercut and slumping into the stream channel on outside meander bends. Typical eroding streambank conditions are depicted in **Figure 4-17** and sediment loading results are provided in **Table 4-12**.

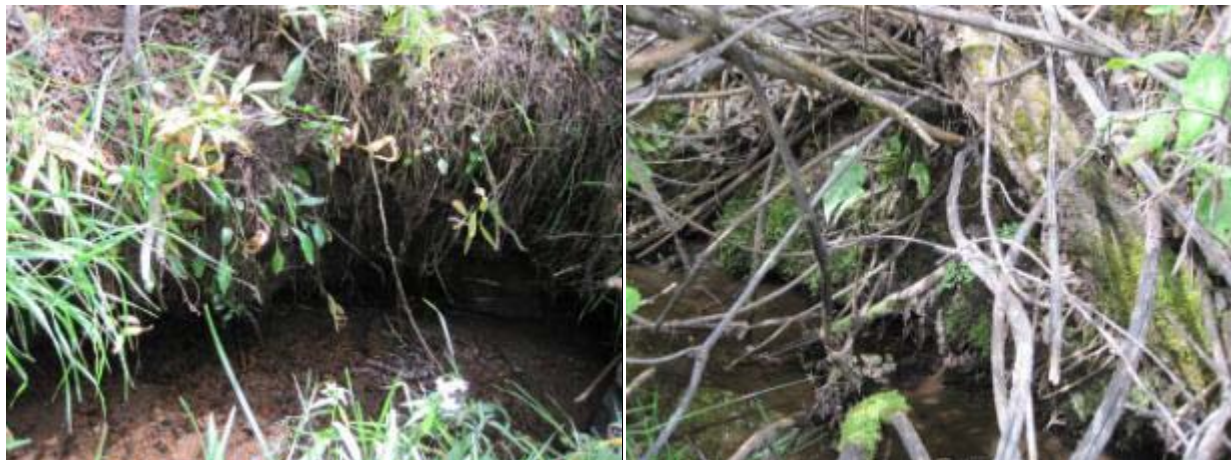
Figure 4-18. Typical eroding streambank conditions in McCarty Creek Reach 22-01.

This reach has eleven slowly eroding banks and seven actively eroding banks. Slowly eroding banks are typically near vertical or undercut with stabilizing vegetation. Actively eroding banks occur where woody vegetation has died, or on tight meander bends. Erosion appears partially due to the severe downcutting observed in this reach. Typical eroding streambank conditions are depicted in **Figure 4-18** and sediment loading results are provided in **Table 4-13**.

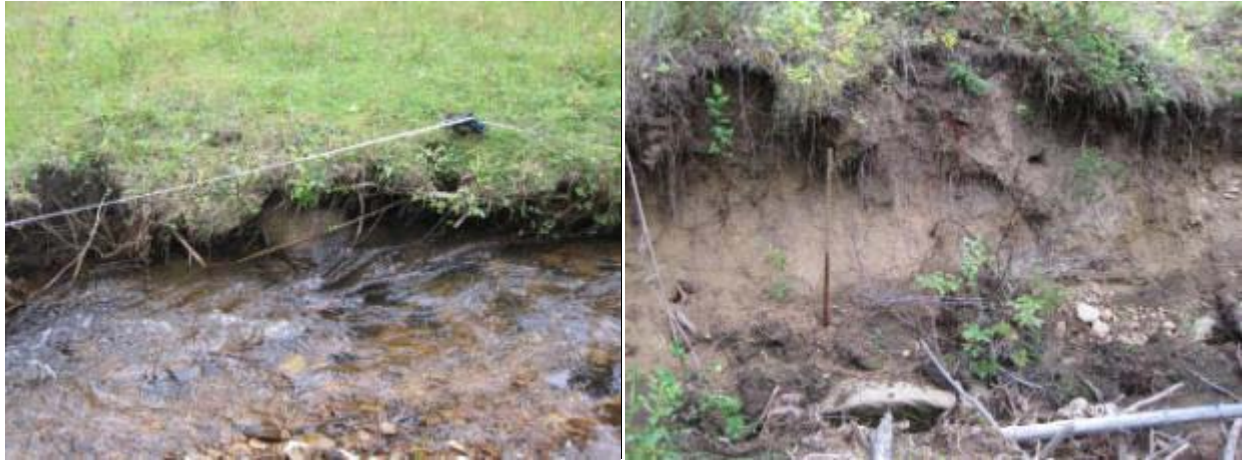
Figure 4-19. Typical eroding streambank conditions in Muskrat Creek Reach 18-01-02.

slowly eroding conditions found within this reach and the right photos shows the mass wasting site that is presently separated from the main channel.

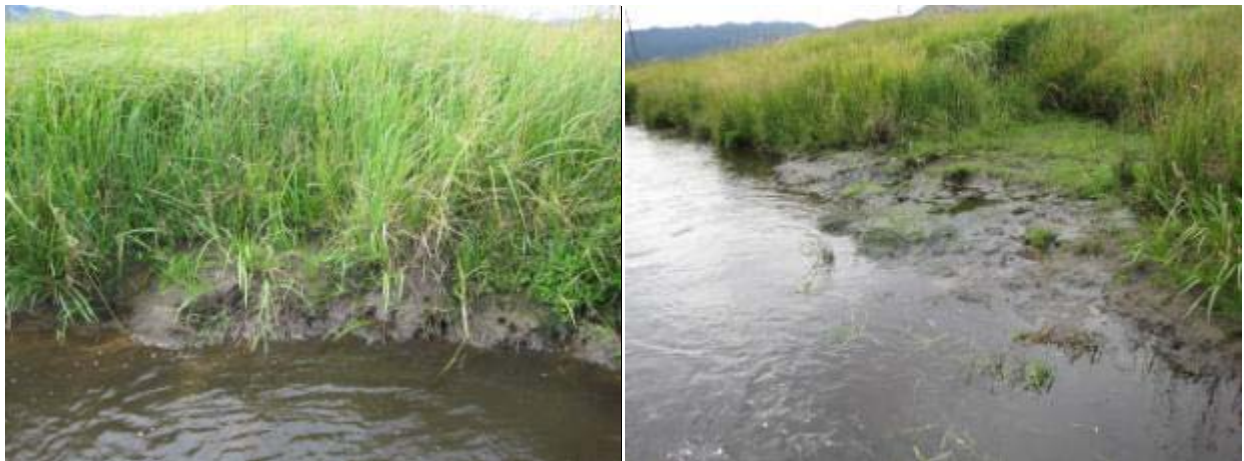
Figure 4-20. Typical eroding streambank conditions in Muskrat Creek Reach 22-08.

This site has numerous slowly eroding banks that are generally well vegetated with low NBS due to the straight channel. Some eroding banks are associated with seeps that occur from irrigation recharge. Typical eroding streambank conditions are depicted in **Figure 4-20** and sediment loading results are provided in **Table 4-14**.

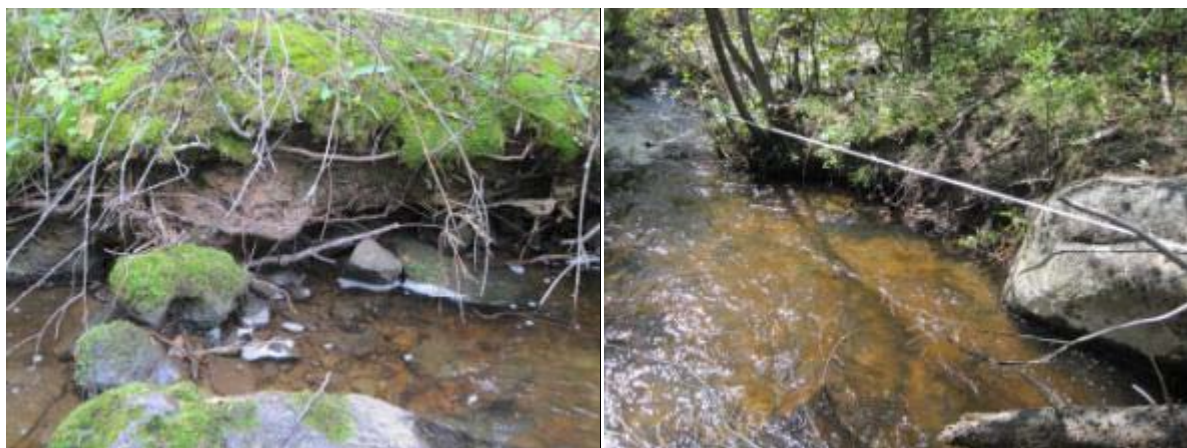
Figure 4-21. Typical eroding streambank conditions in North Fork Little Boulder 42-01.

This reach has eleven actively eroding streambanks that are generally associated with LWD or boulders that direct streamflow into the bank. Eroding banks are generally short and near vertical or overhanging. Typical eroding streambank conditions are depicted in **Figure 4-21** and sediment loading results are provided in **Table 4-15**.

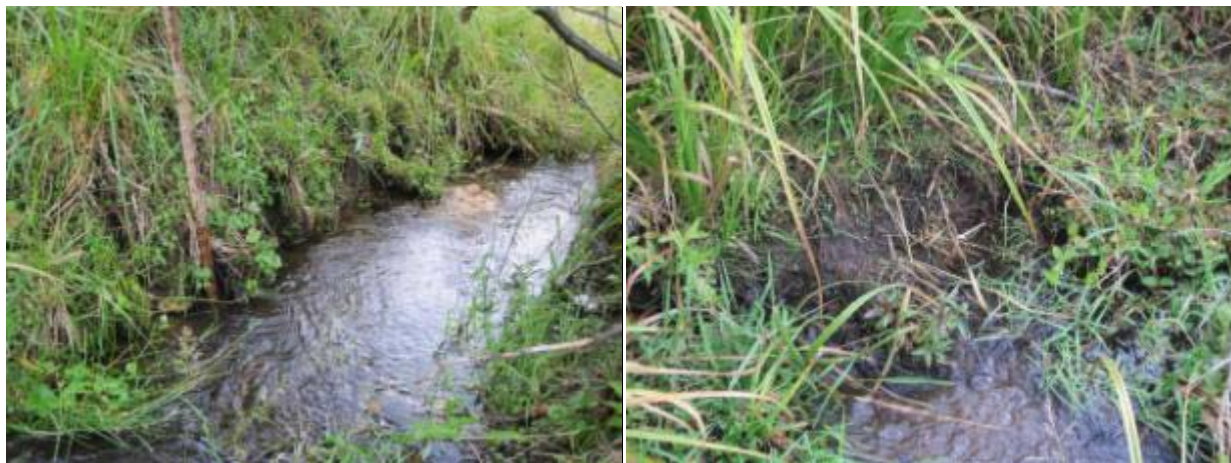
Figure 4-22. Typical eroding streambank conditions in Nursery Creek Reach 07-01.

This reach has seven slowly eroding streambanks that are generally associated with seeps, LWD, or cattle trampling. Lush wetland vegetation stabilizes the banks throughout most of the reach. Typical eroding streambank conditions are depicted in **Figure 4-22** and sediment loading results are provided in **Table 4-16**.
