# Lower Gallatin Watershed Water Quality Assessments and TMDLs

Pete Schade  
Lisa Kusnierz  
Montana DEQ

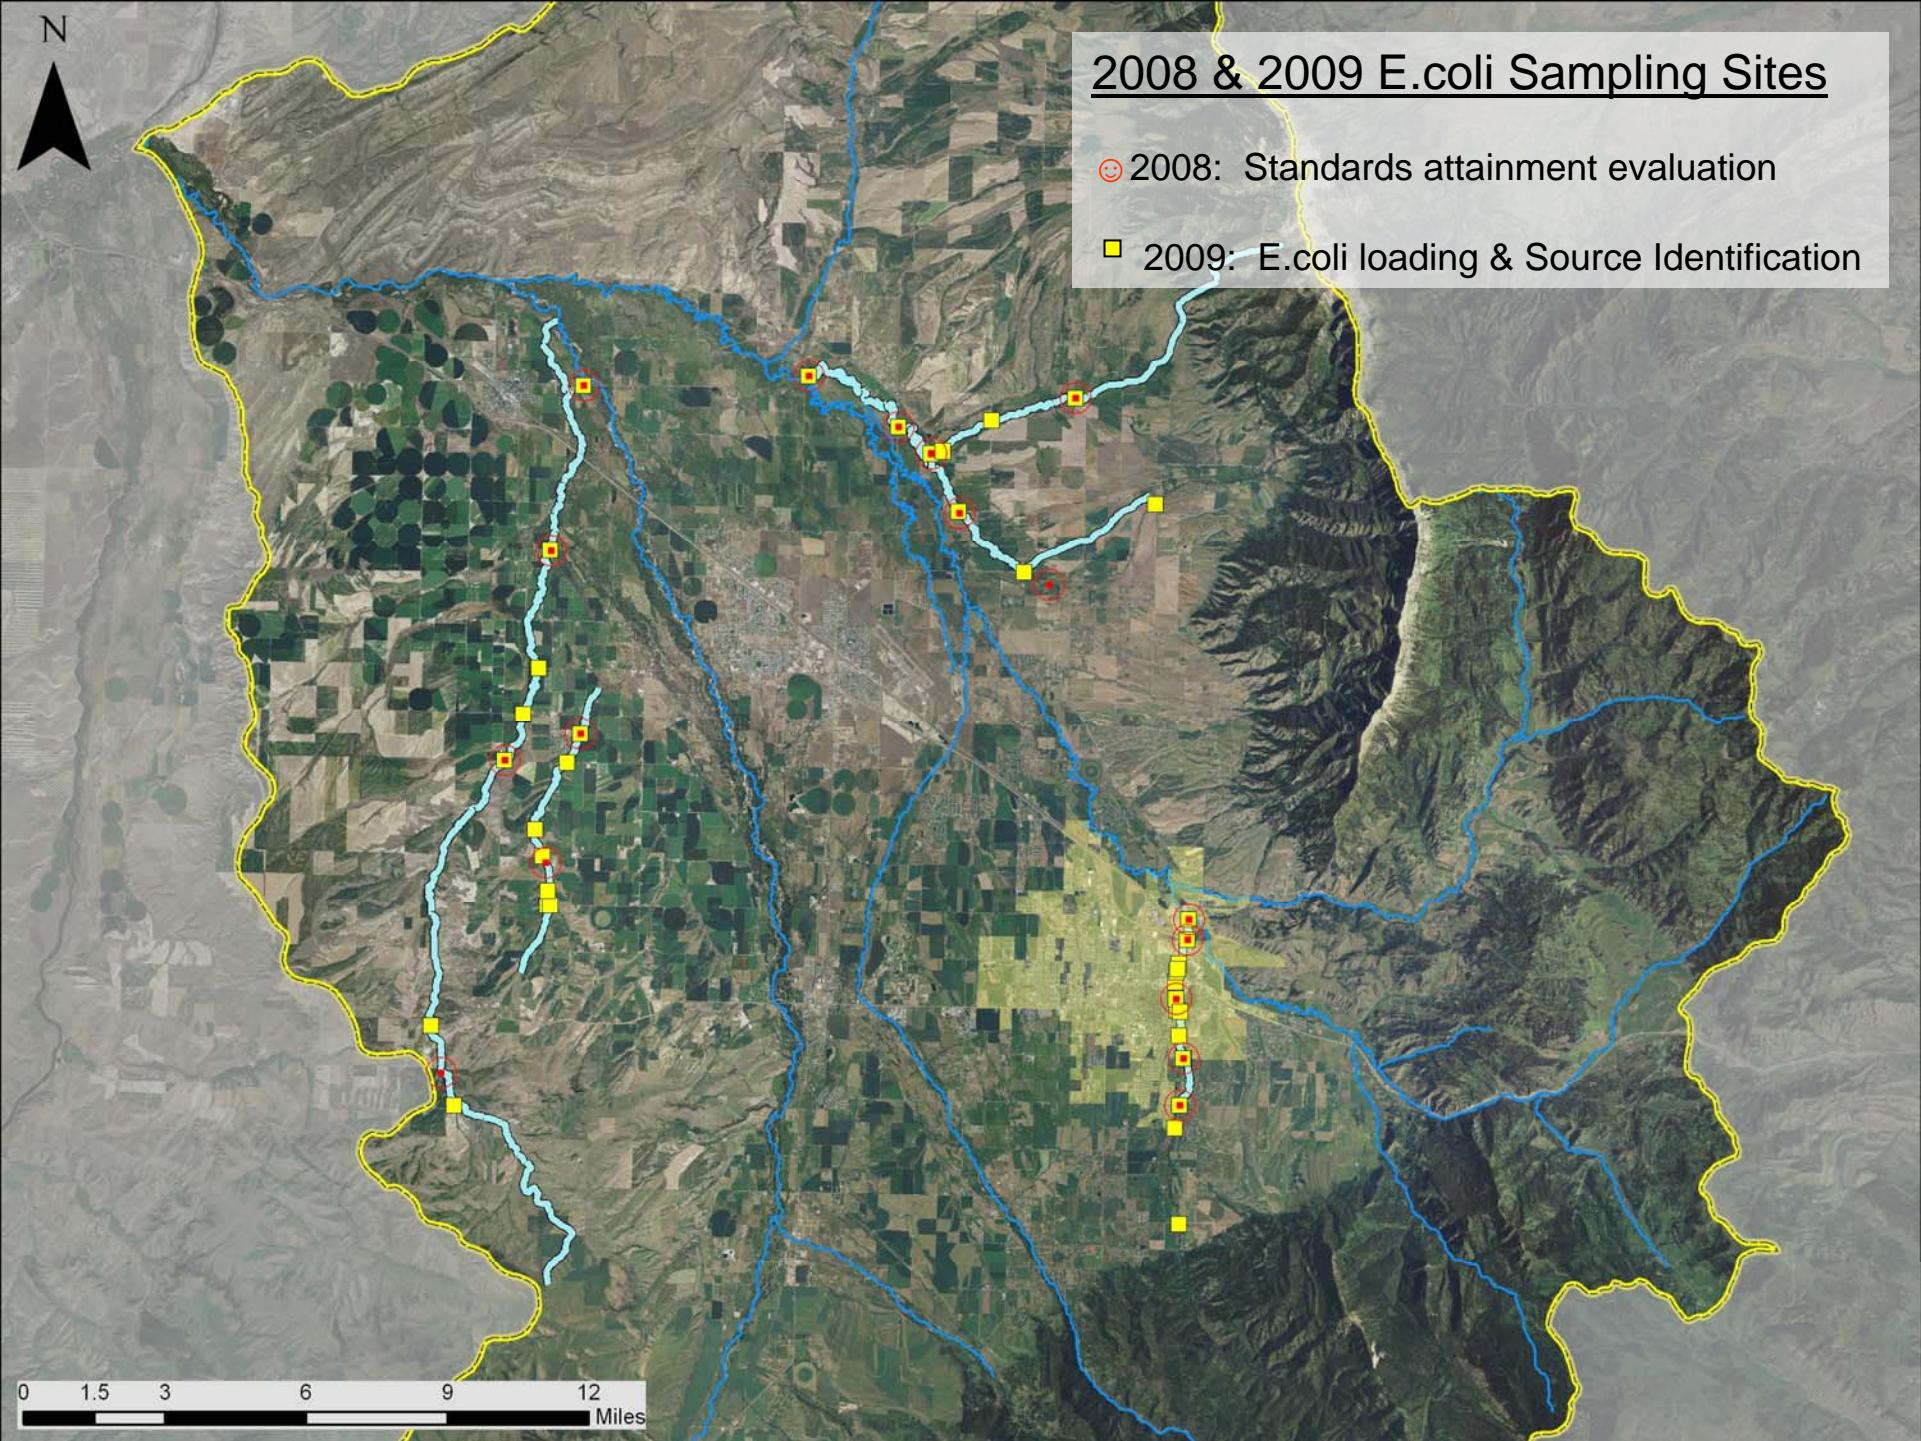
## 2008 & 2009 E.coli Sampling Sites

● 2008: Standards attainment evaluation

■ 2009: E.coli loading & Source Identification

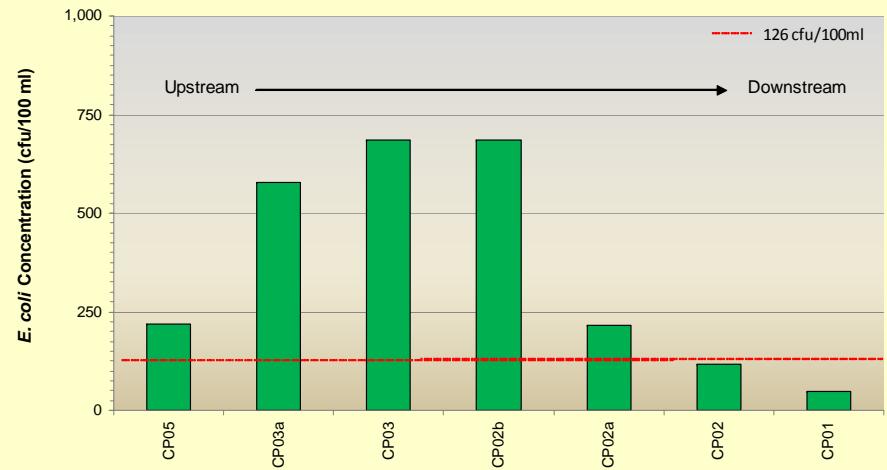
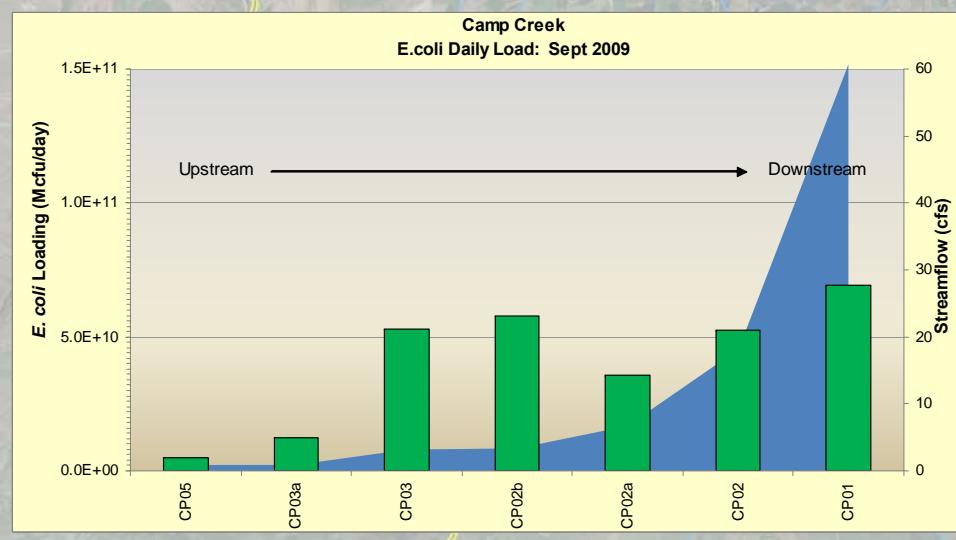
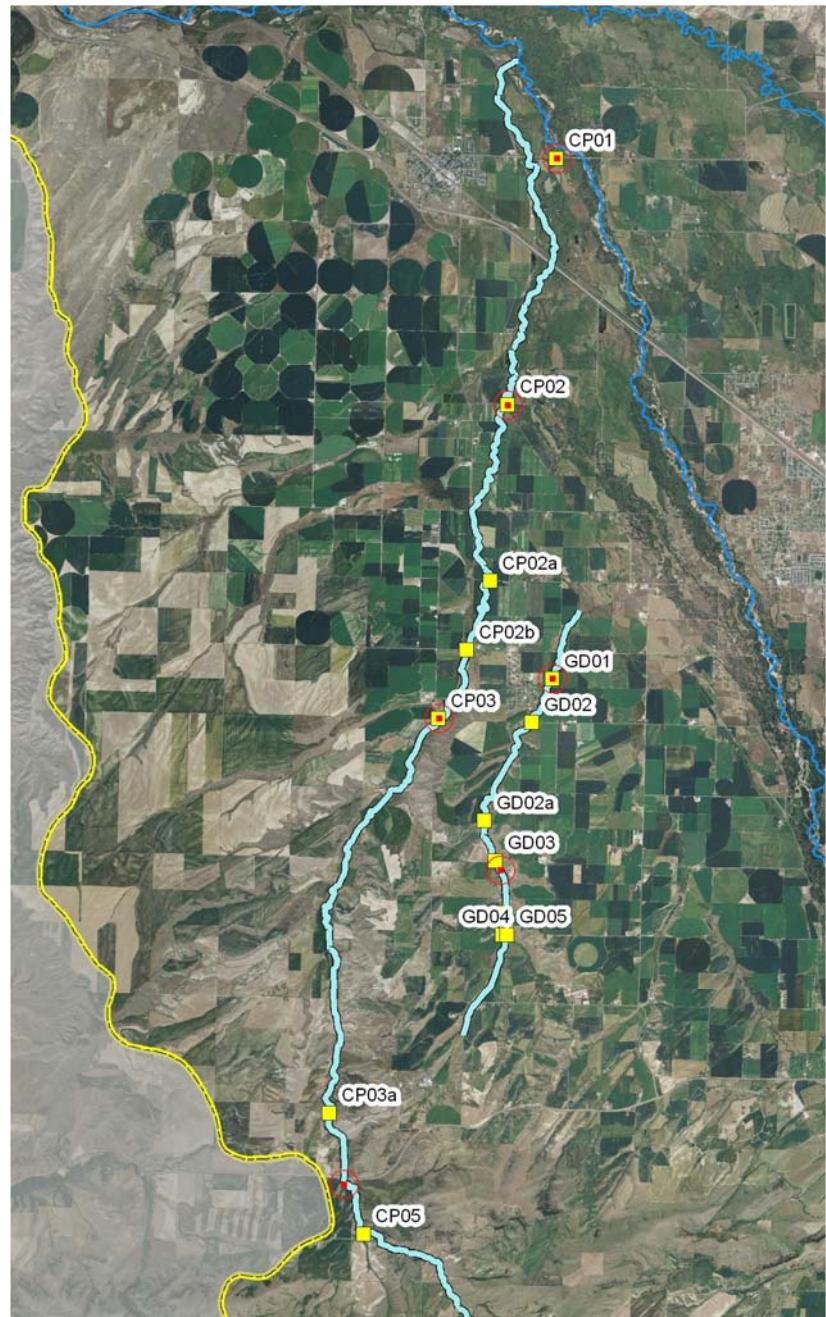
# Camp Creek

**Camp Creek**  
E.coli Sampling Results: Sept 2009

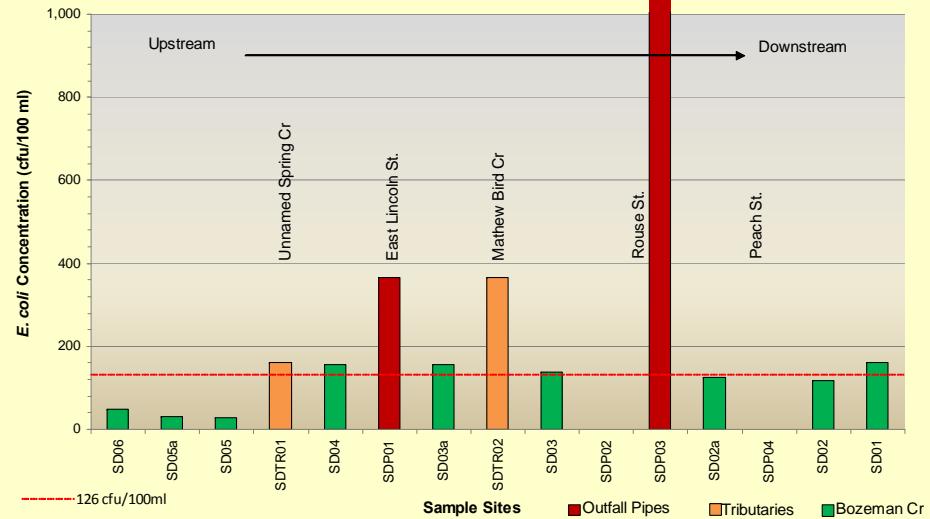
Sourdough/Bozeman Creek  
E.coli Sampling Results: Sept 2009

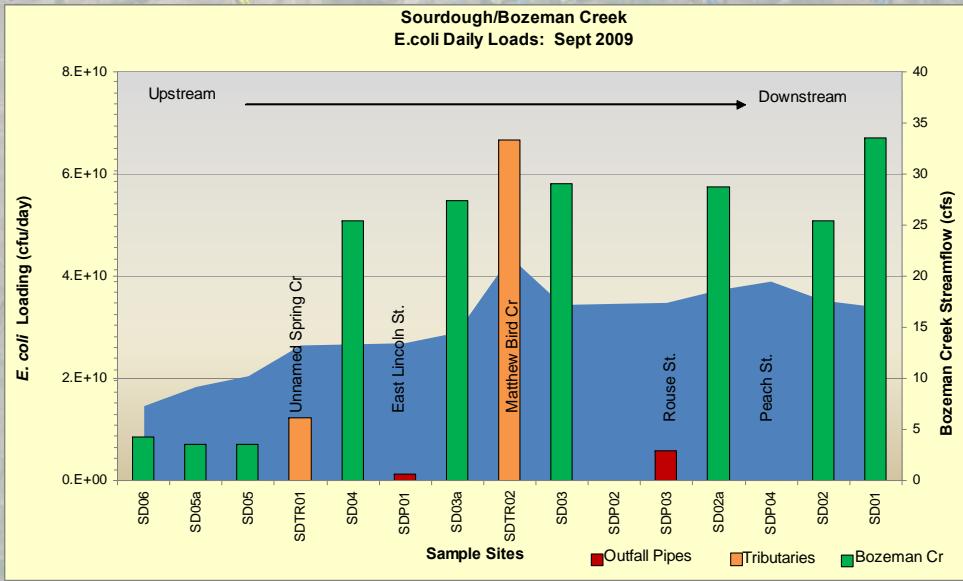
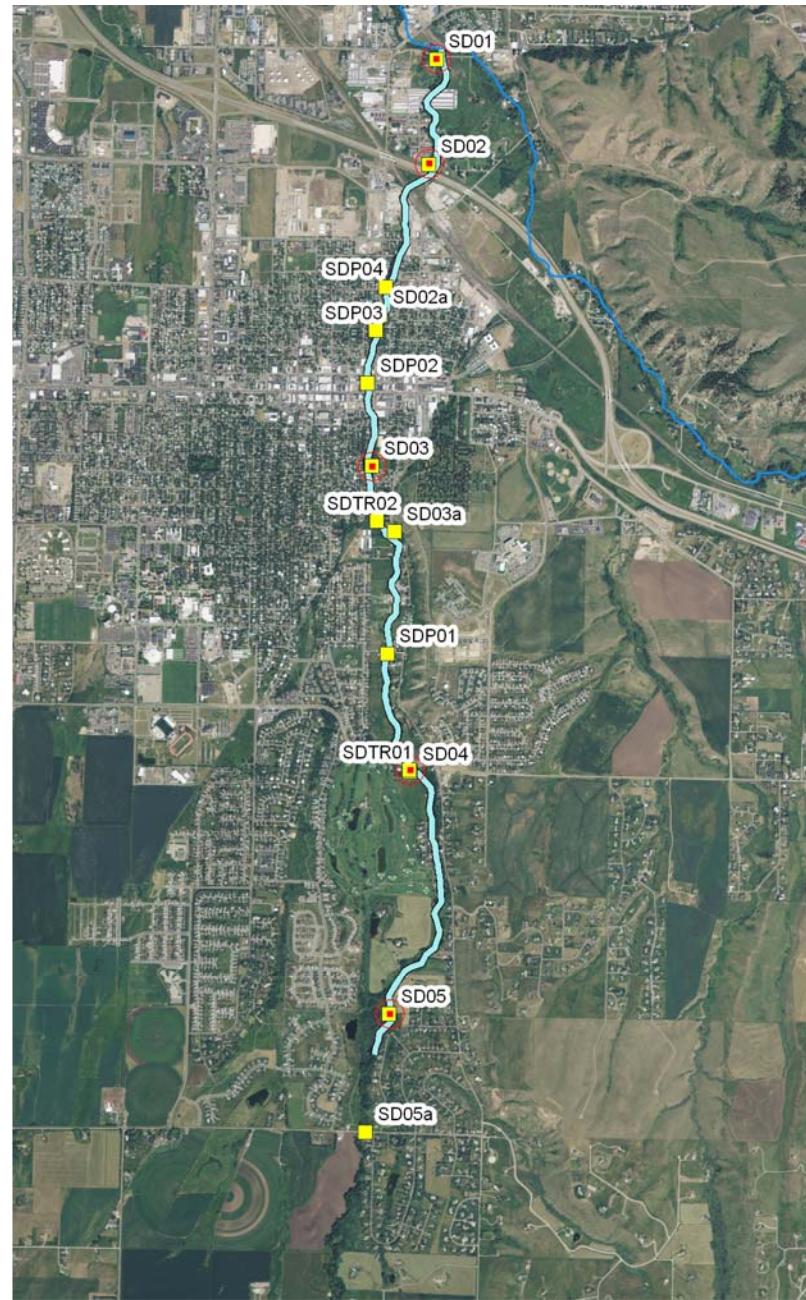
Sourdough/Bozeman Creek  
E.coli Daily Loads: Sept 2009

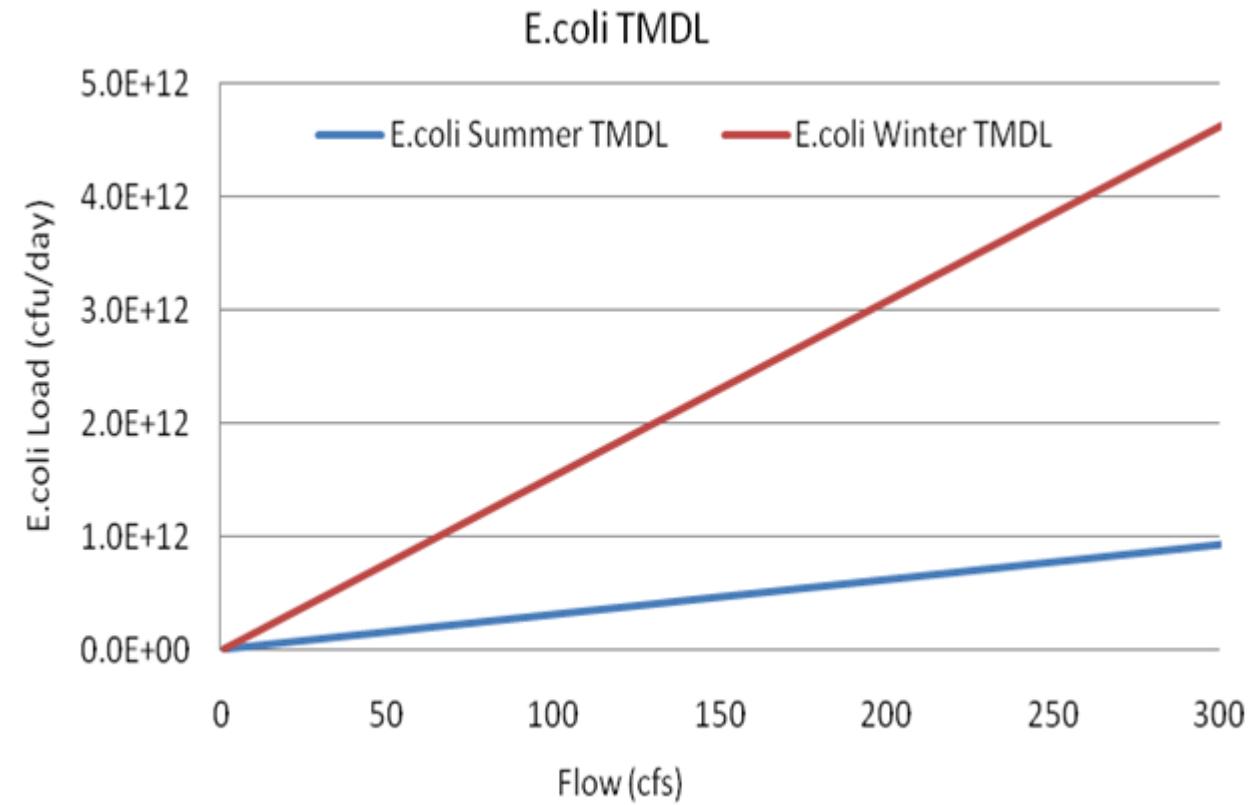
$$TMDL = (X) (Y) (2.44E+7)$$

TMDL= Total Maximum Daily Load in cfu/day

X= e.coli water quality target in cfu/100ml (126 summer, 630 winter)

Y= streamflow in cubic feet per second

(2.44E+7) = conversion factor

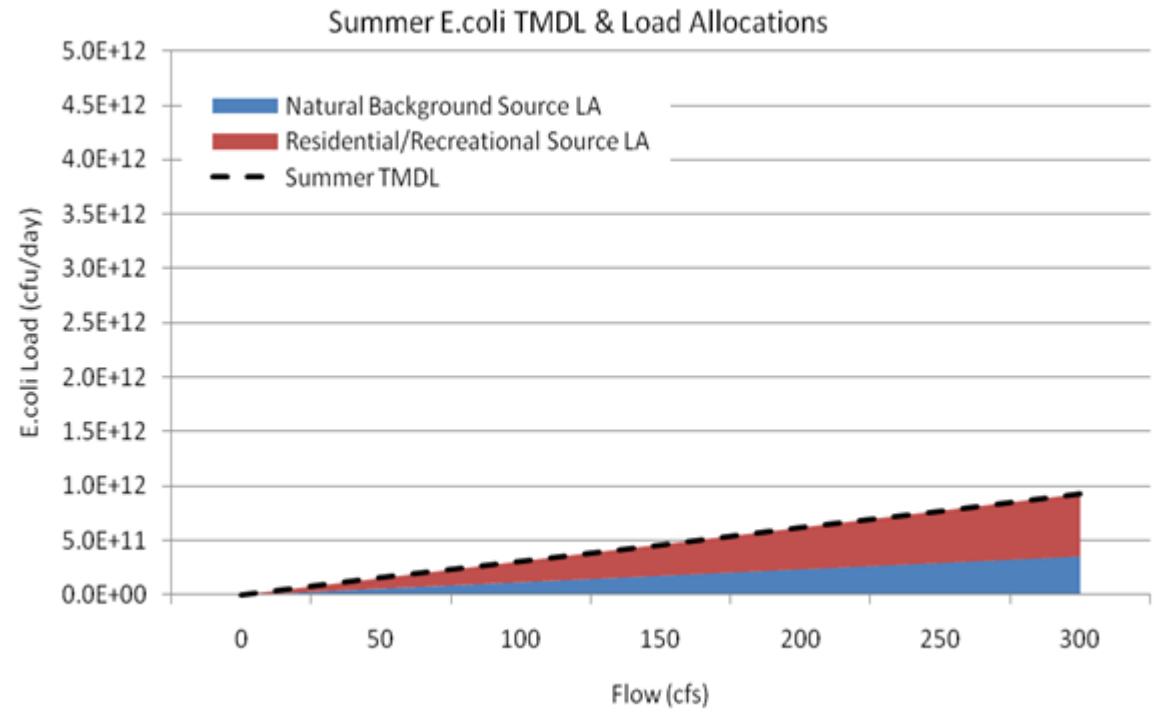
$$TMDL = \sum WLA + \sum LA + MOS$$

$$TMDL = WLA + LA_{NB} + LA_{ag} + LA_{RES}$$

*WLA = Wasteload Allocation to urban stormwater sources*

*LA<sub>NB</sub> = Load Allocation to natural background sources*

*LA<sub>ag</sub> = Load Allocation to agricultural sources*

*LA<sub>RES</sub> = Load Allocation to residential/recreational land use sources*

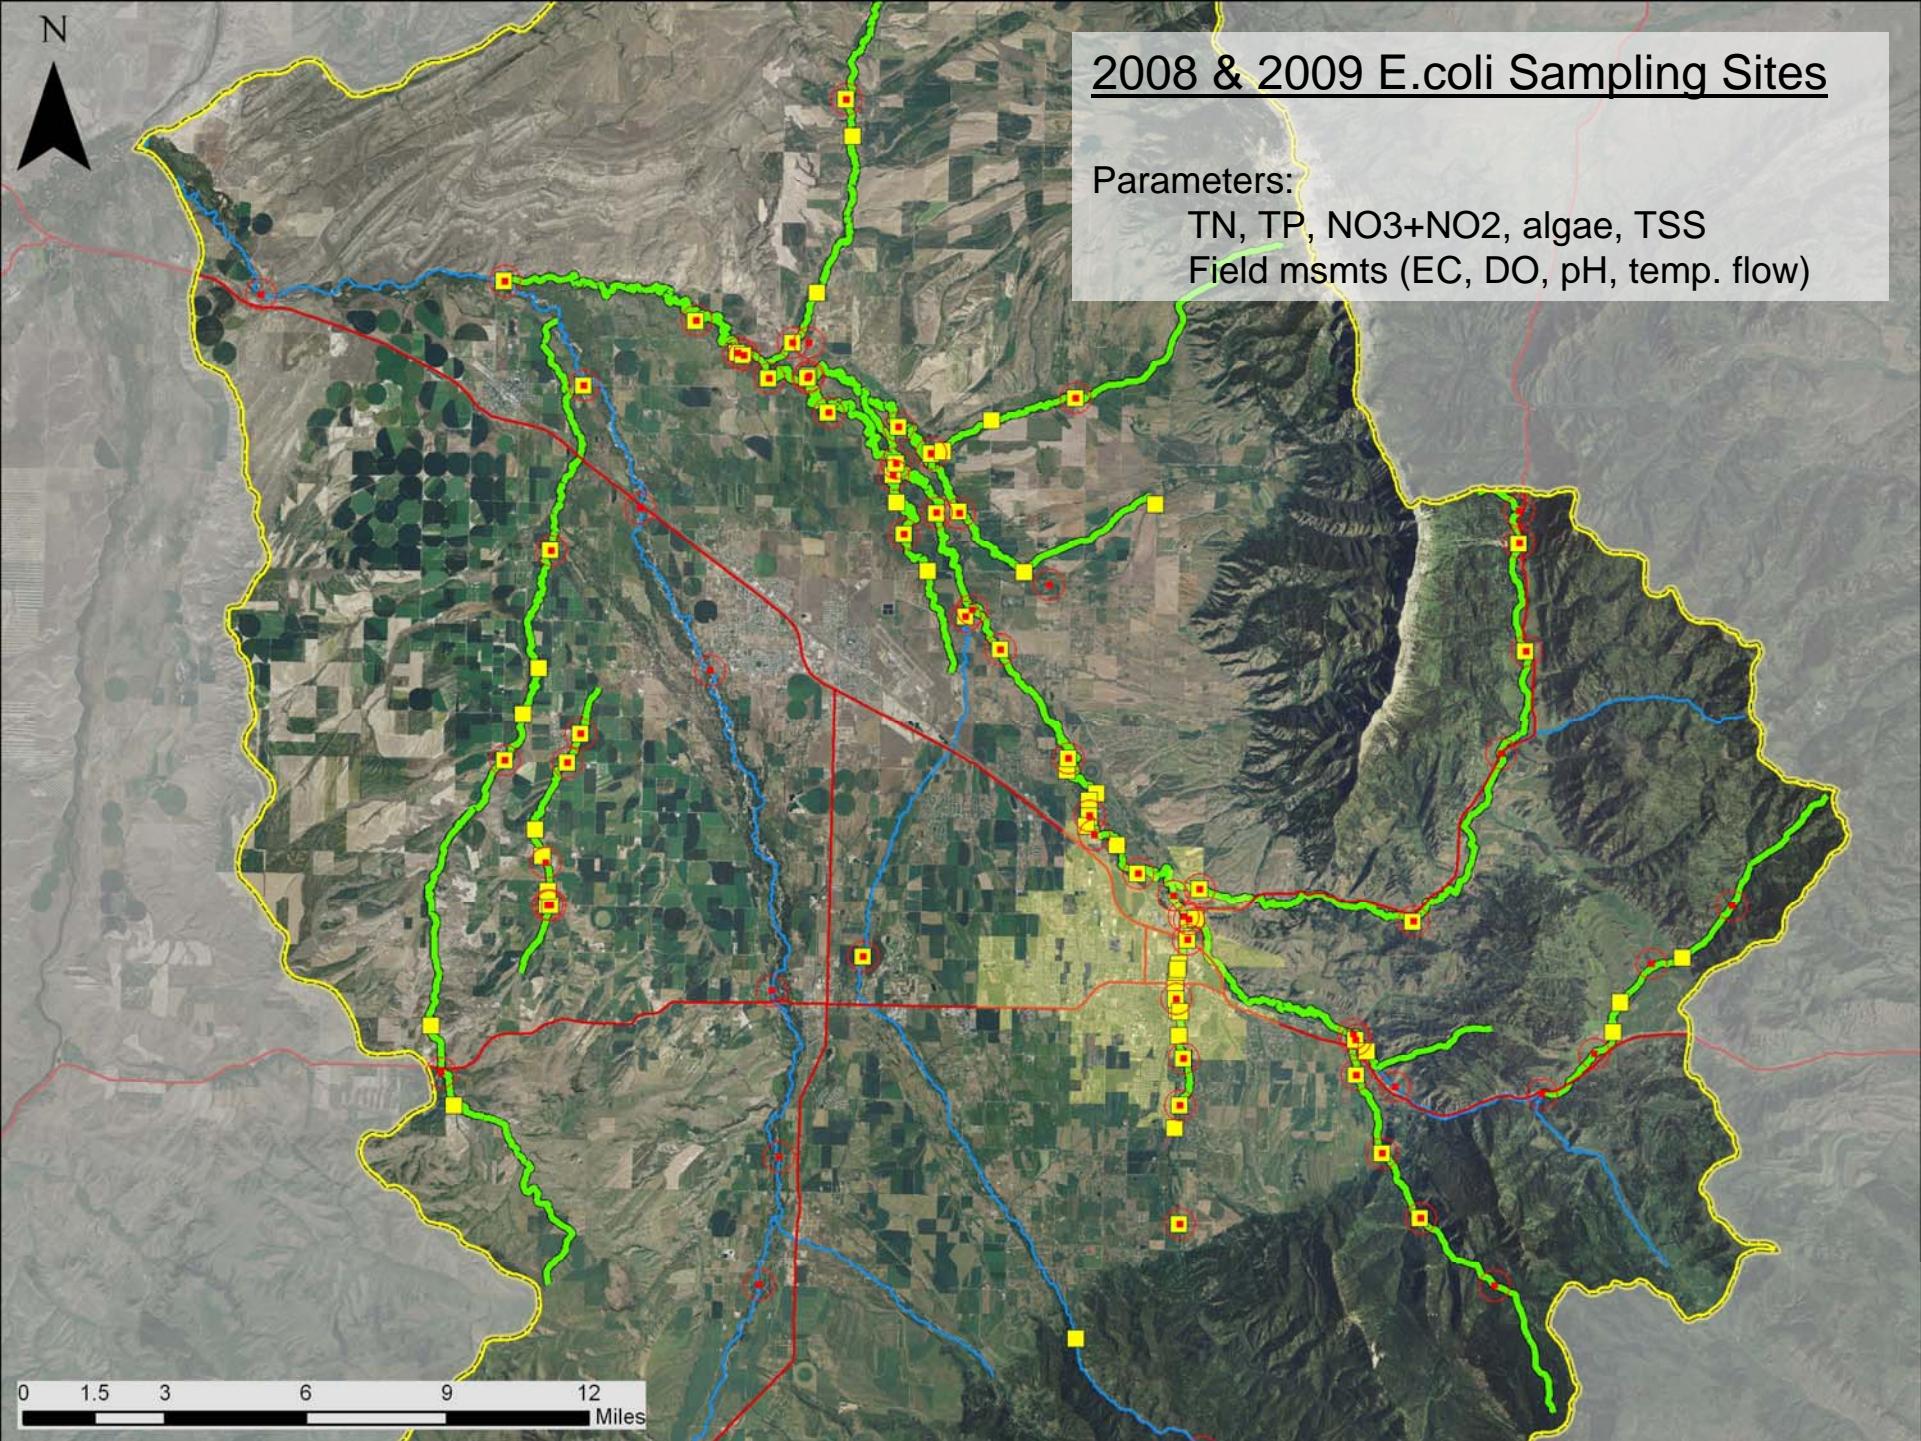
## 2008 & 2009 E.coli Sampling Sites

Parameters:

TN, TP, NO<sub>3</sub>+NO<sub>2</sub>, algae, TSS

Field msmts (EC, DO, pH, temp. flow)

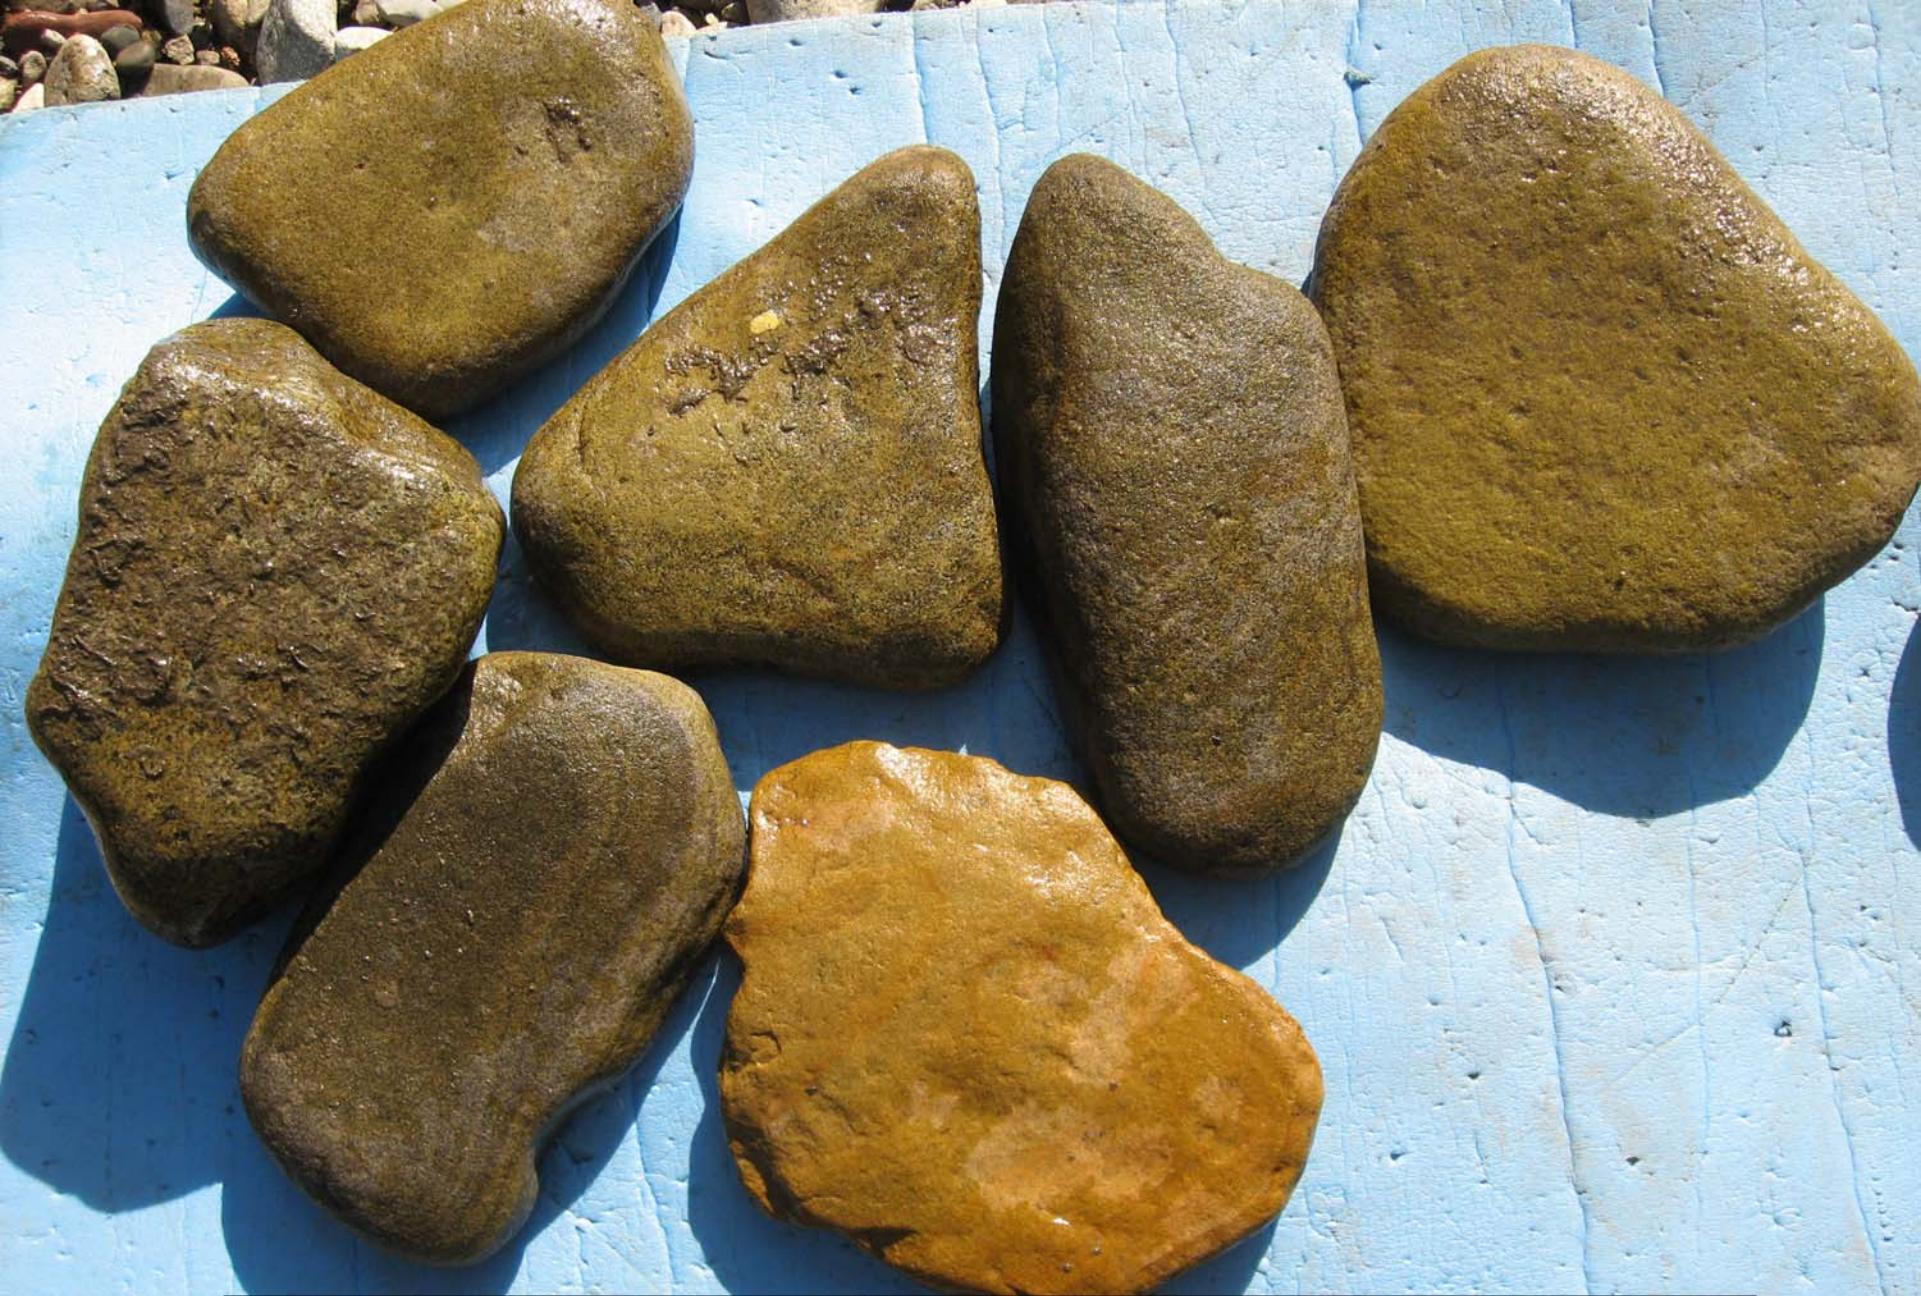
Low Algal Concentrations (<50 mg/m<sup>2</sup> chlorophyll-a)

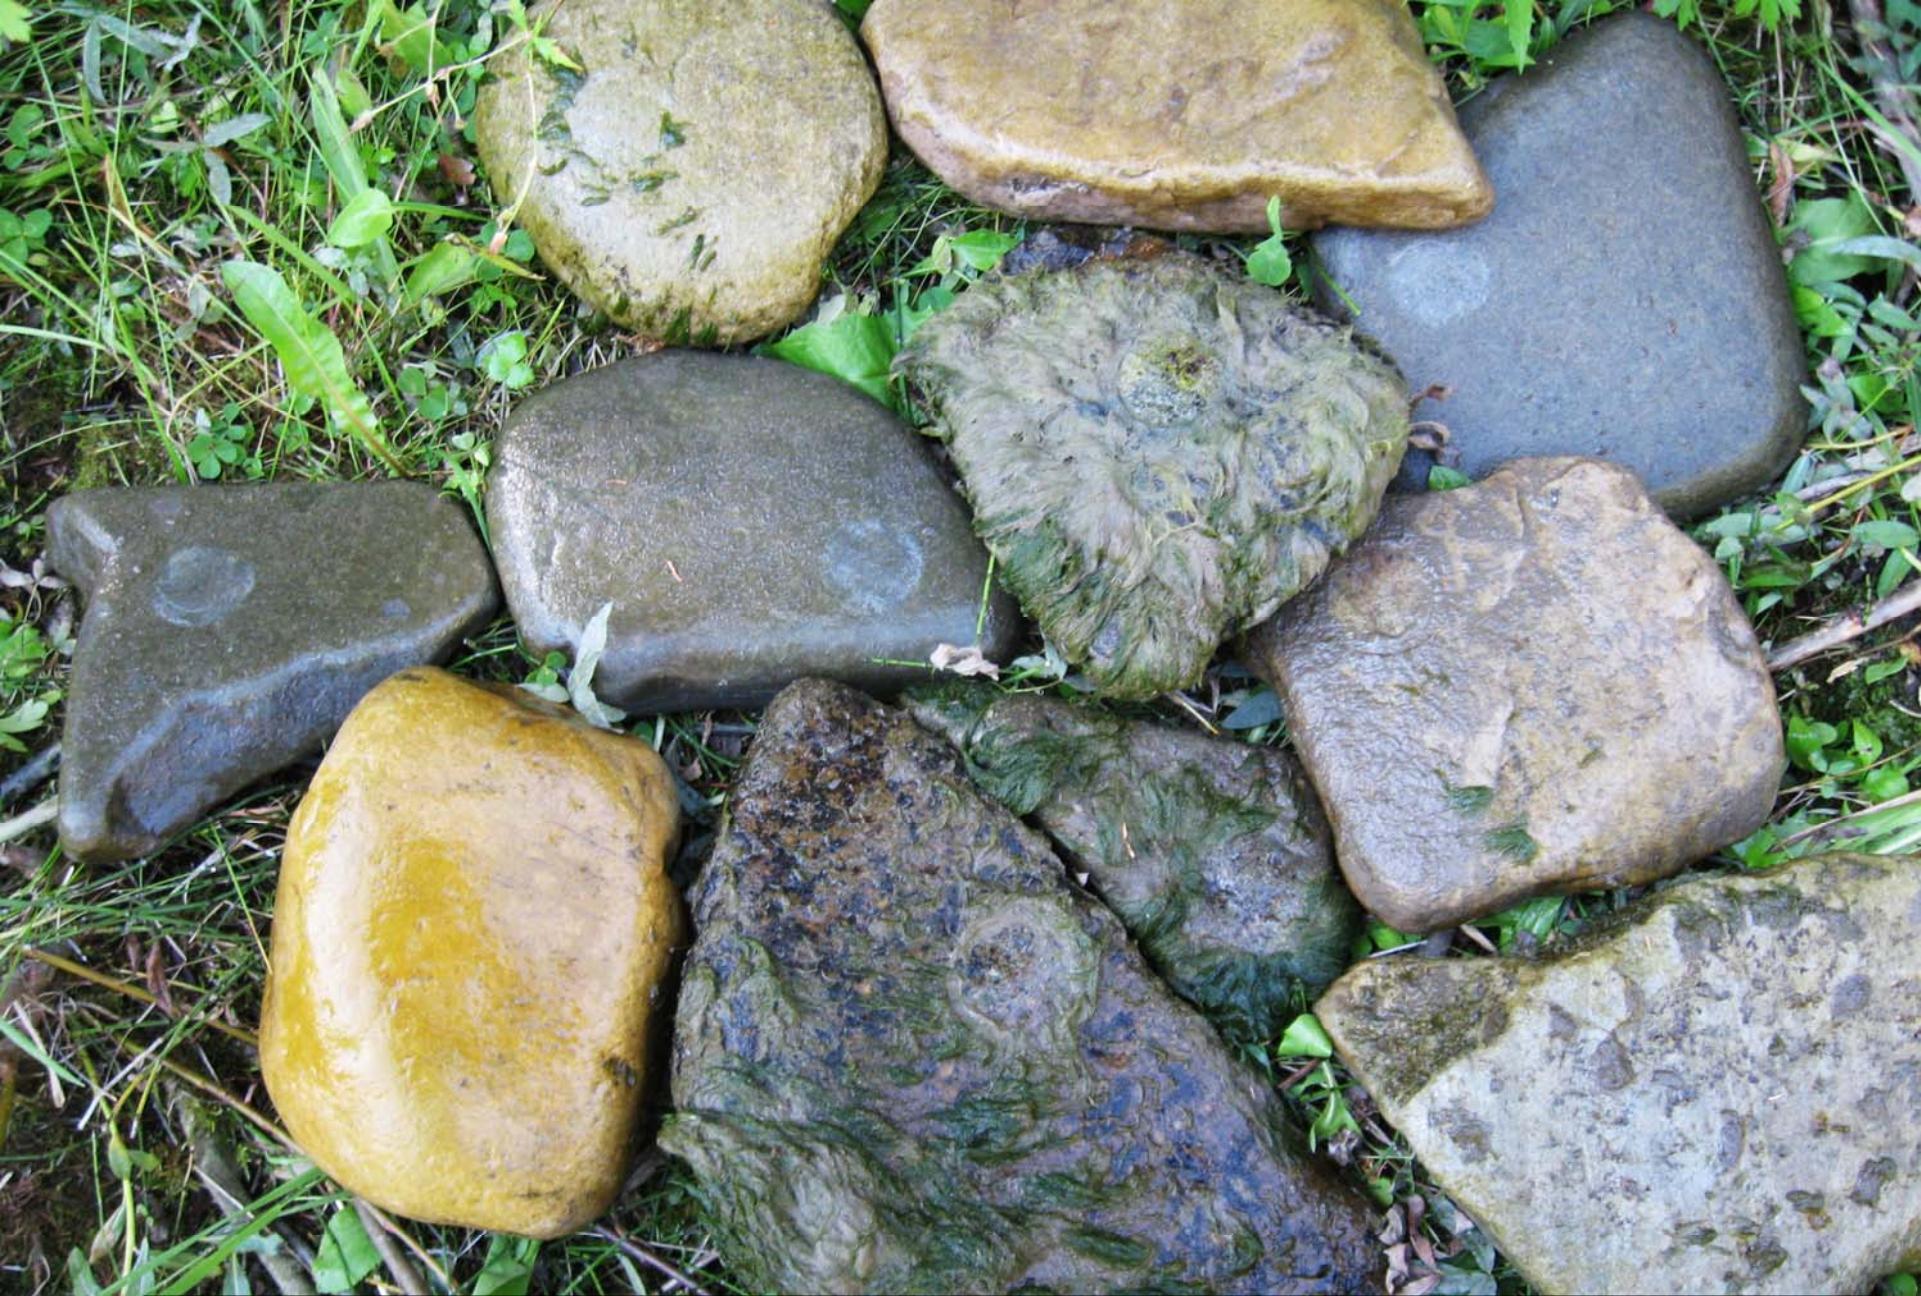
Medium Algal Concentrations (50-100 mg/m<sup>2</sup> chlorophyll-a)

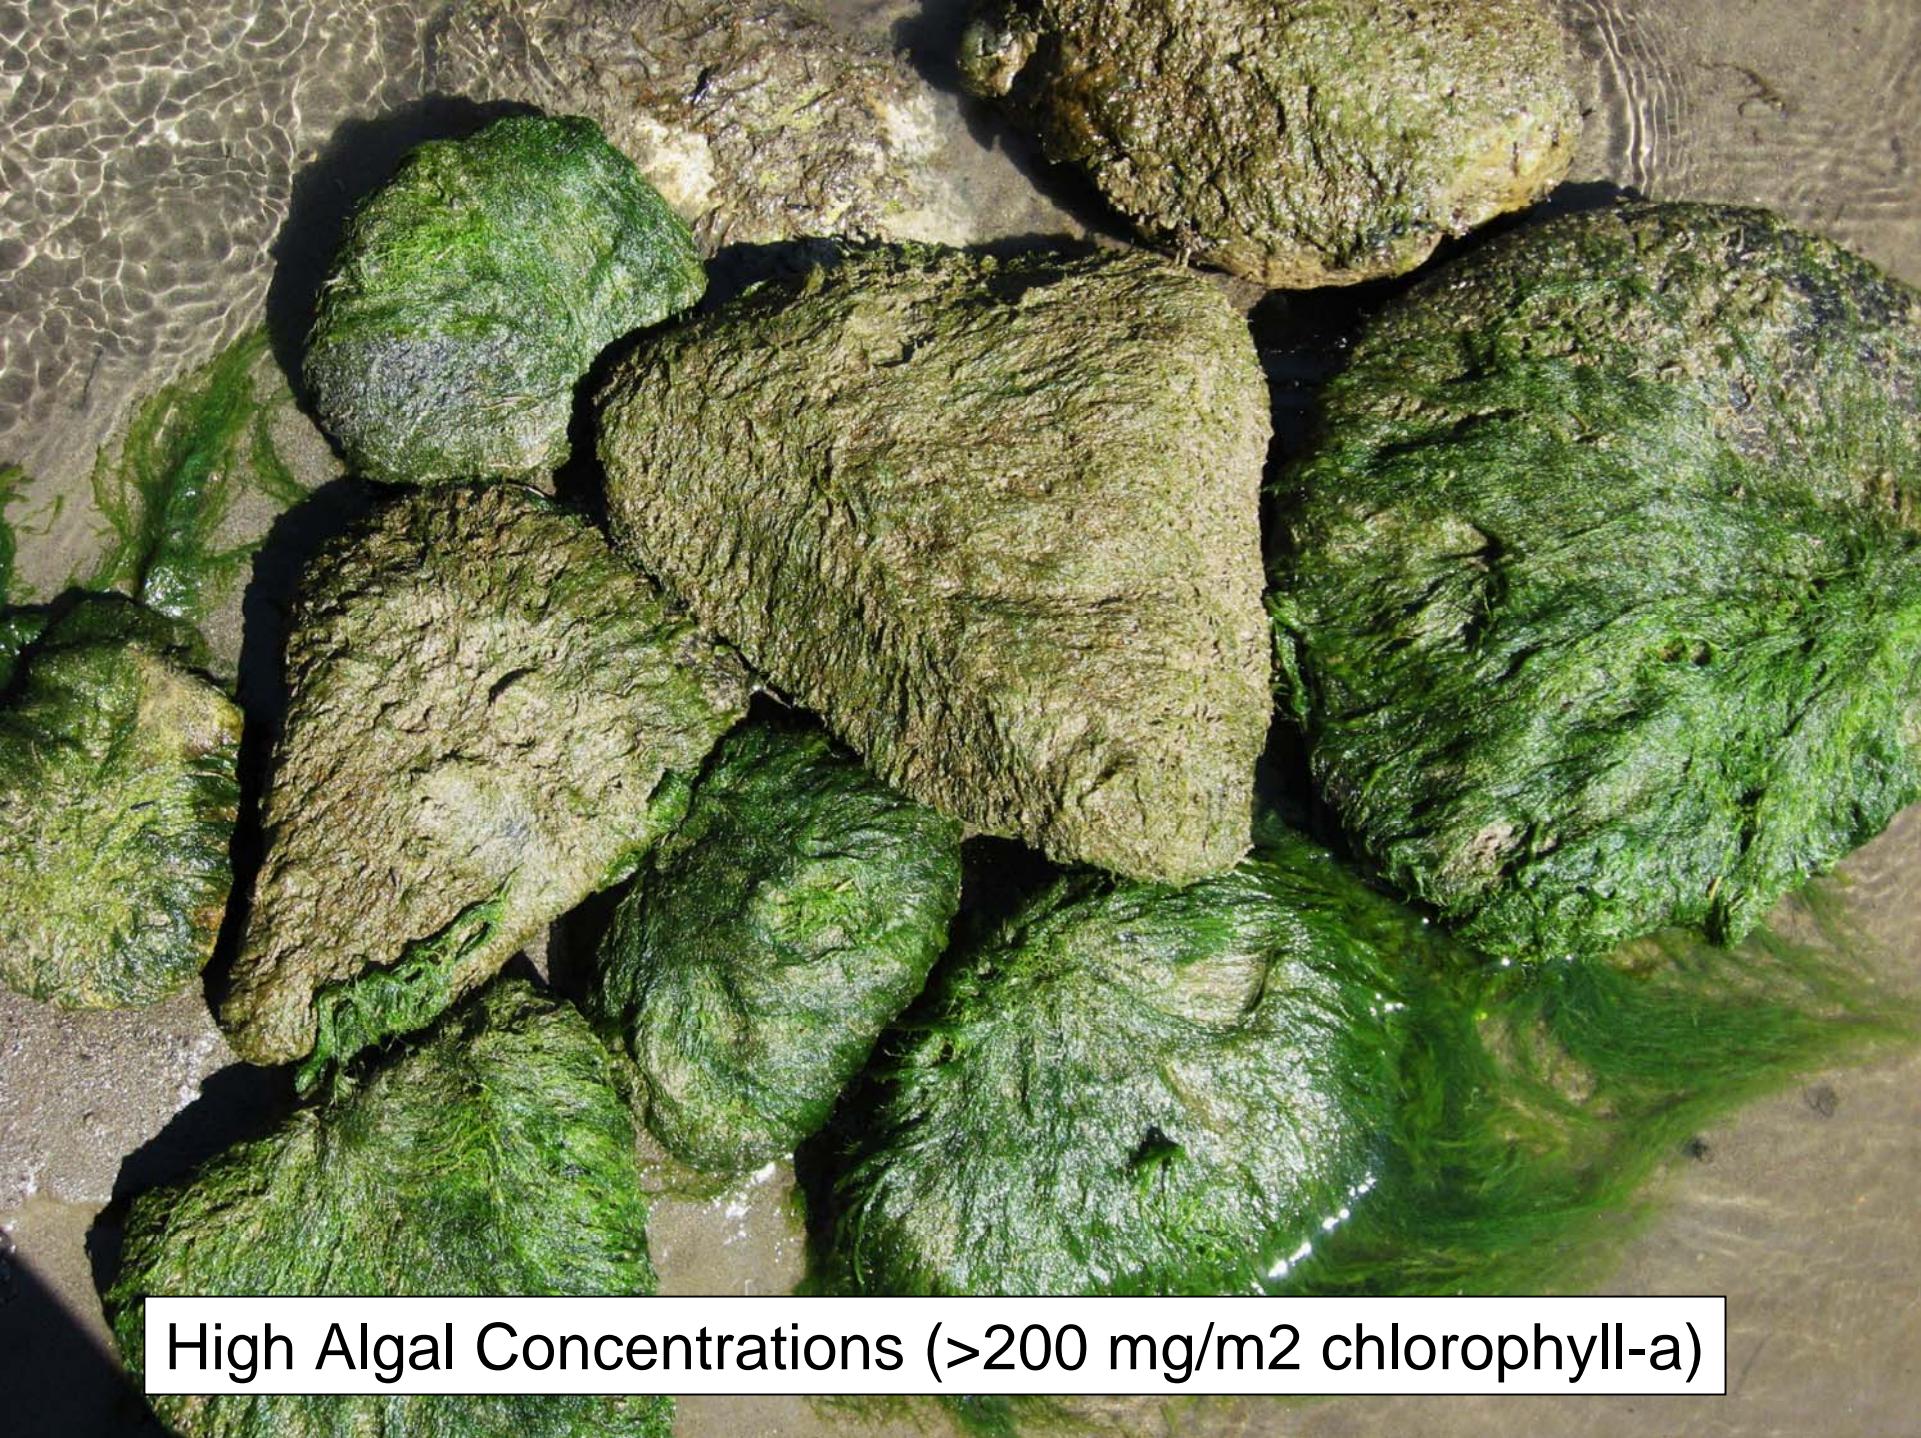
High Algal Concentrations (>200 mg/m<sup>2</sup> chlorophyll-a)

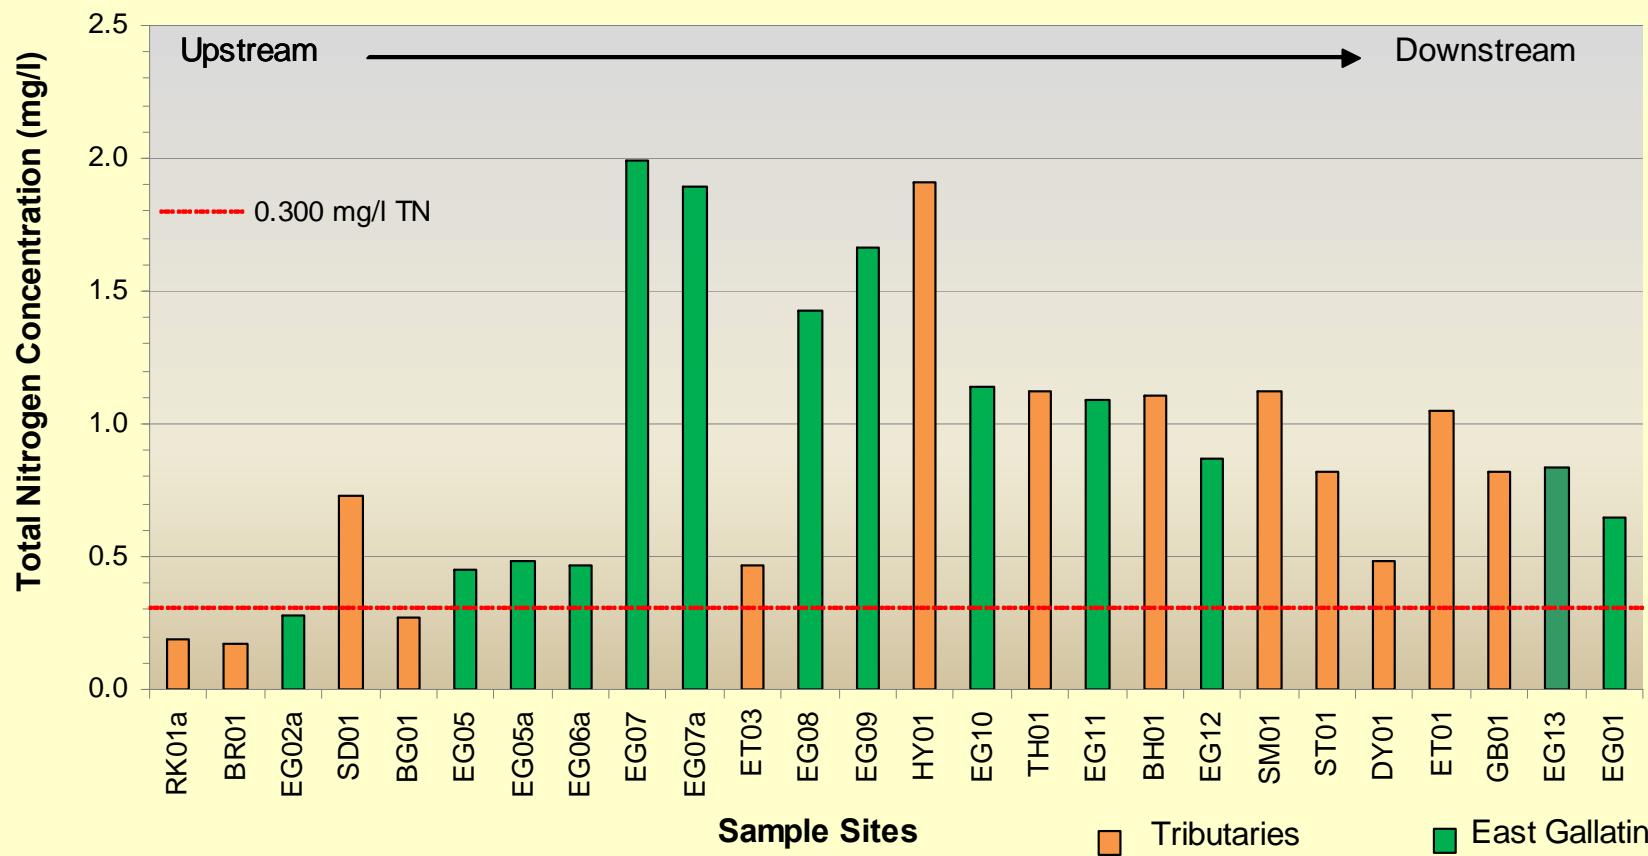
# East Gallatin Total Nitrogen Results, Sept 2009

## TN Concentrations

East Gallatin River and Tributaries

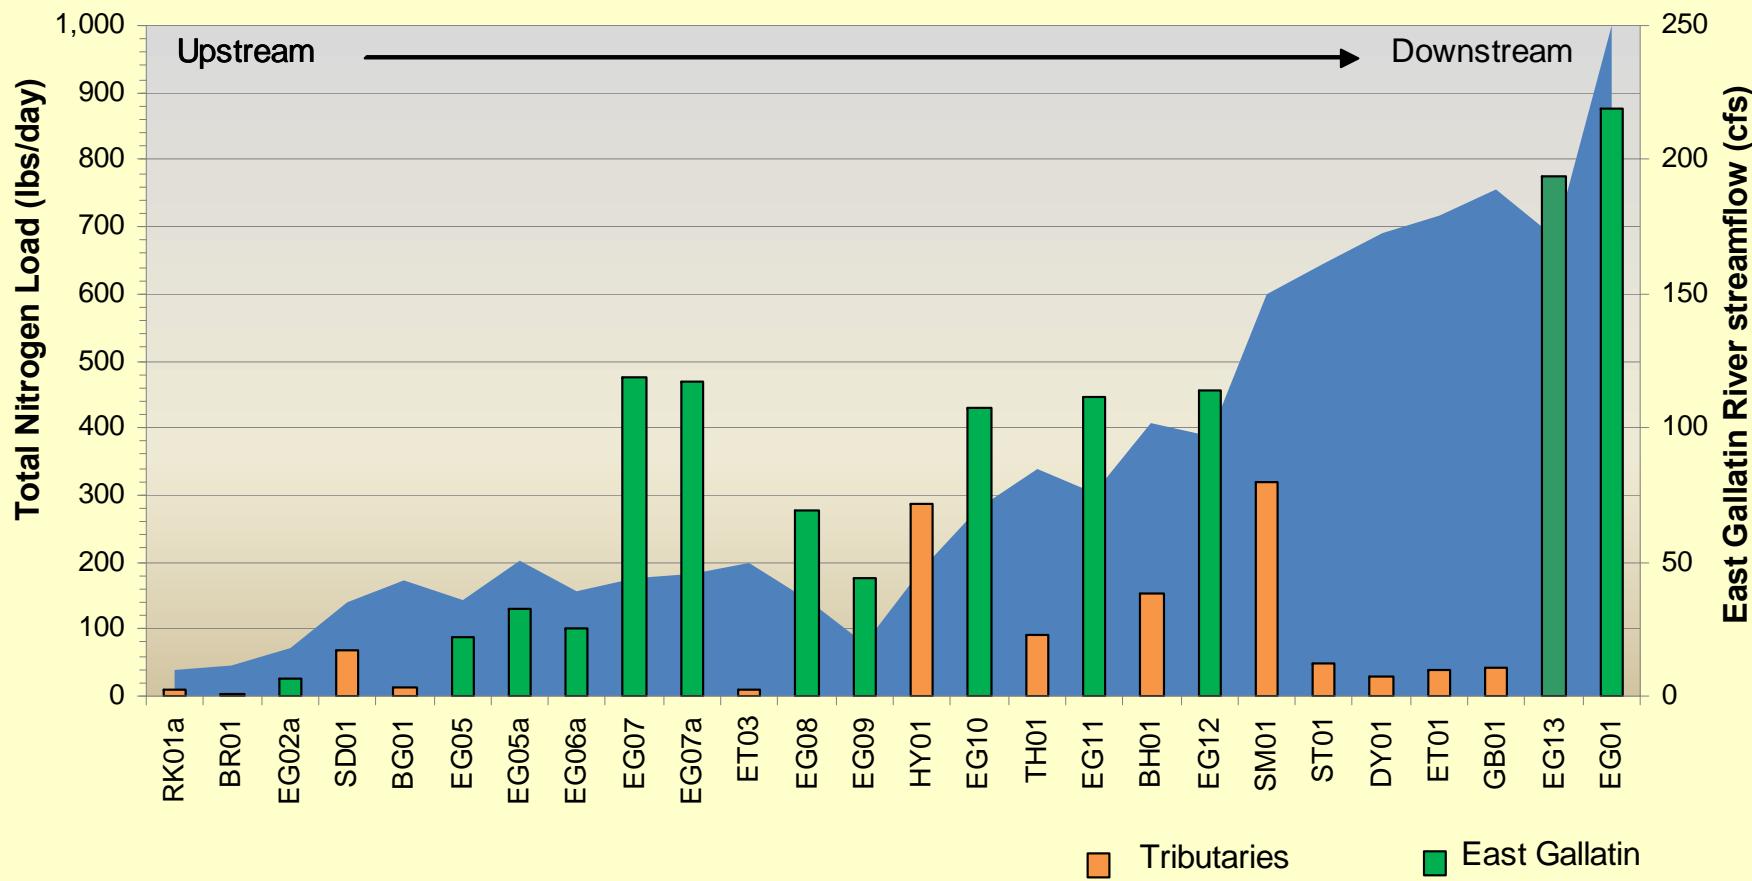
# East Gallatin Total Nitrogen Results, Sept 2009

TN Loads

East Gallatin River and Tributaries
