# Lower Gallatin Watershed Water Quality Assessments and TMDLs

Pete Schade  
Lisa Kusnierz  
Montana DEQ

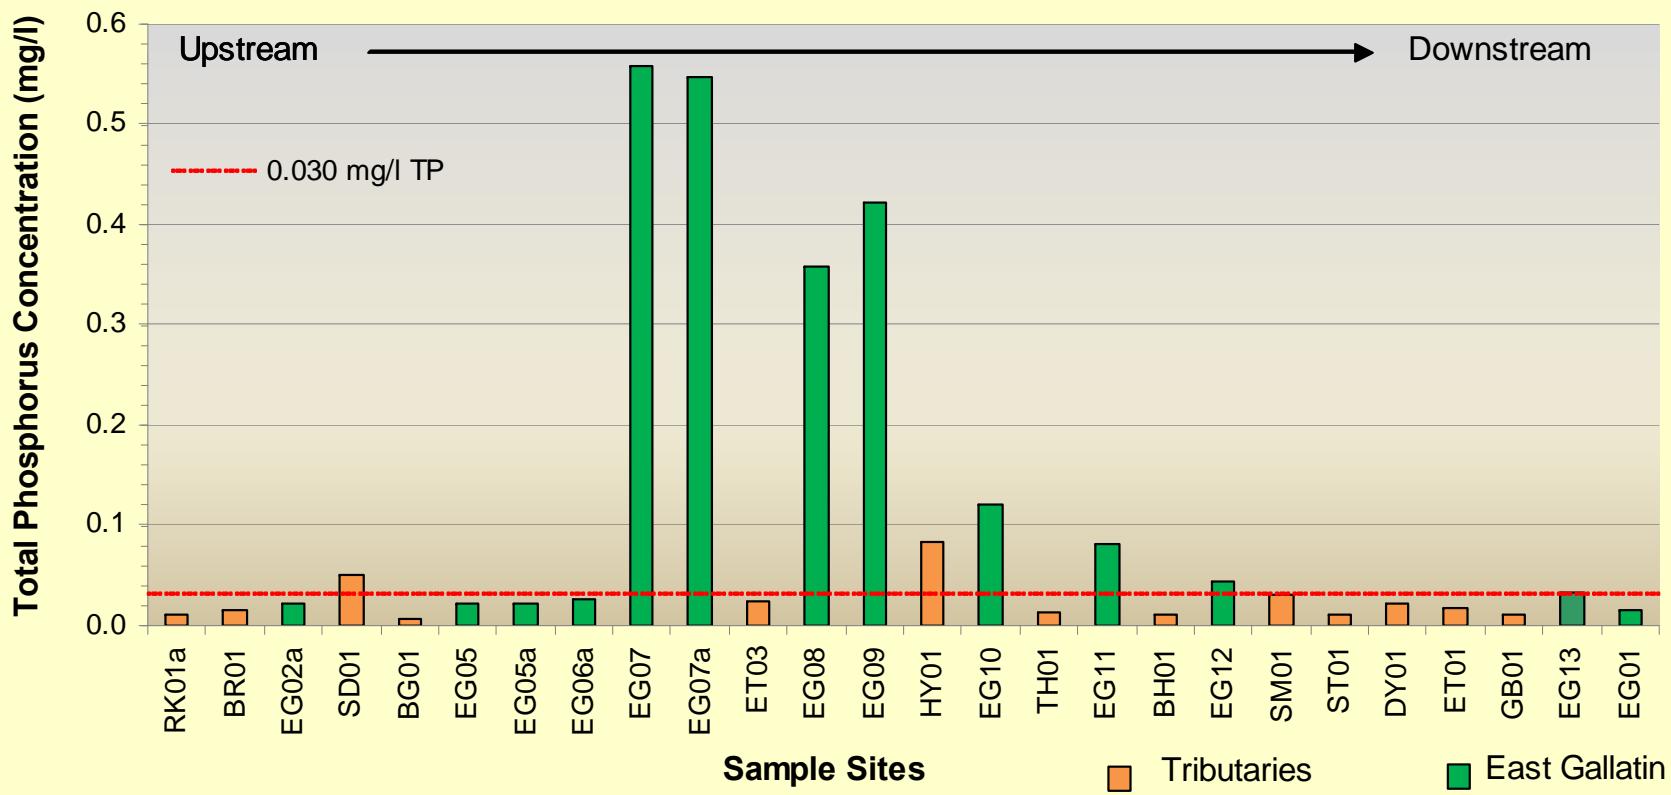
# East Gallatin Total Phosphorus Results, Sept 2009

## TP Concentrations

East Gallatin River and Tributaries

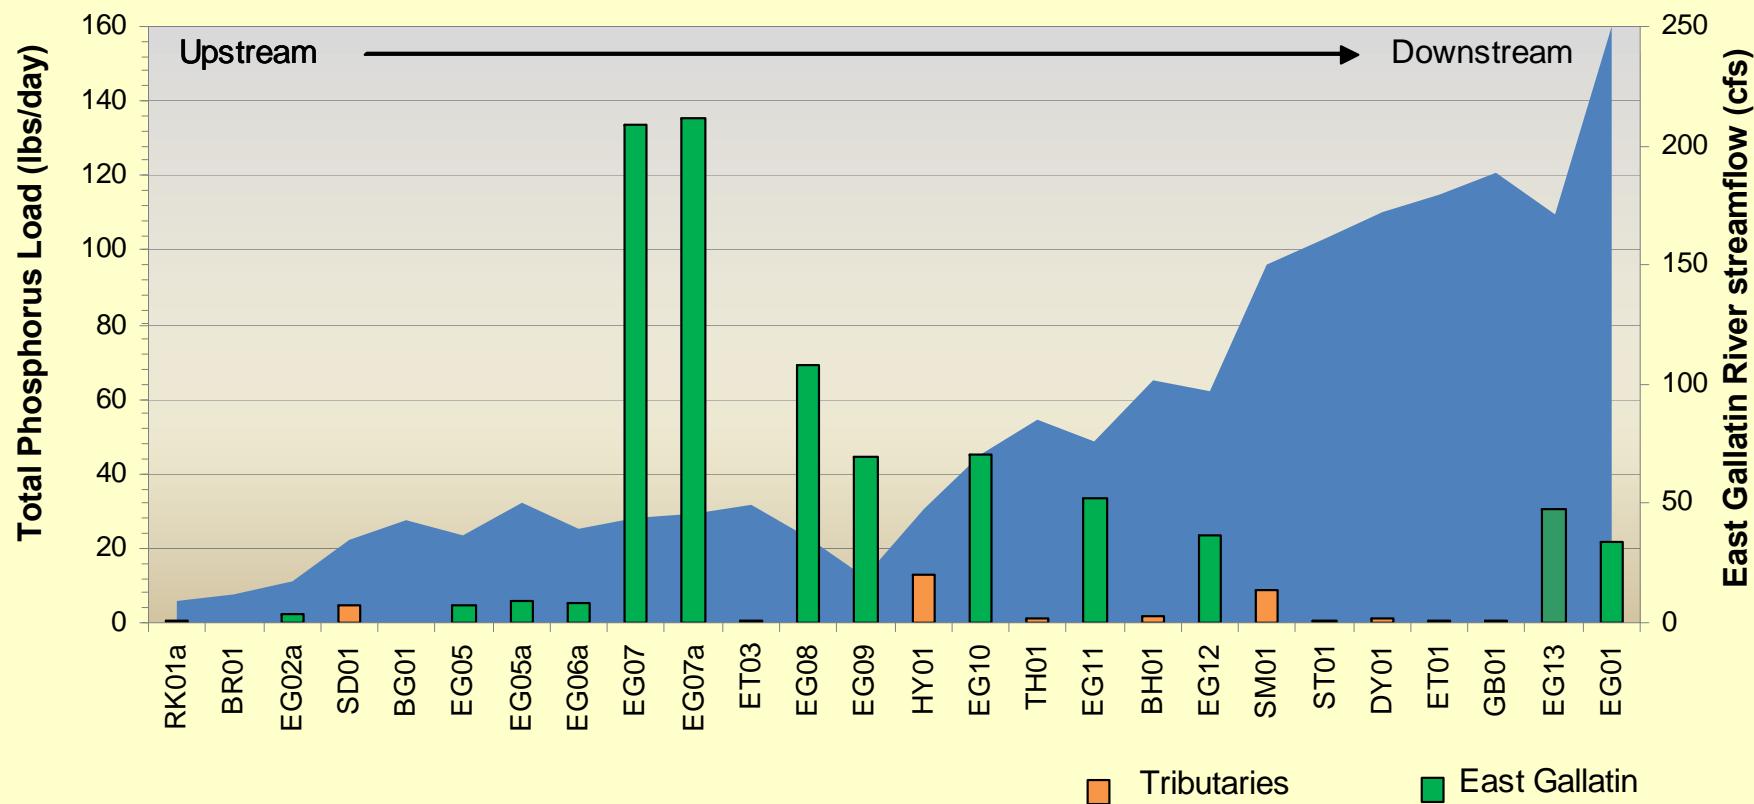
# East Gallatin Total Phosphorus Results, Sept 2009

TP Loads

East Gallatin River and Tributaries

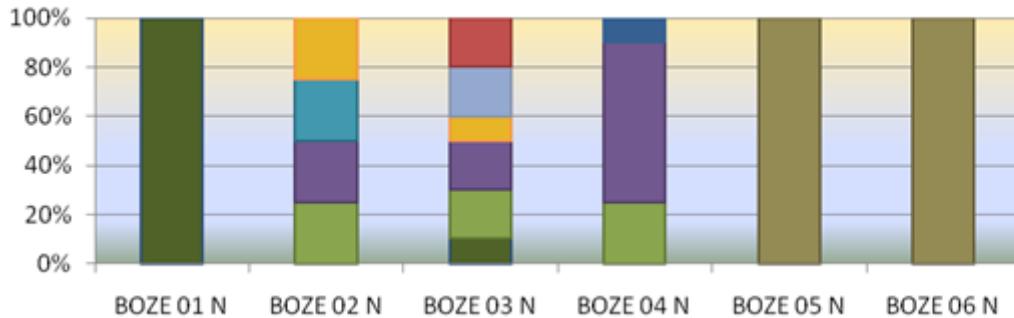
Left Bank Land Use on Sourdough Creek

- Rural Res.
- Urban
- Residential
- Golf
- Dry Crops
- Irr. Crops
- Dry Pasture
- Irr. Pasture
- Forest

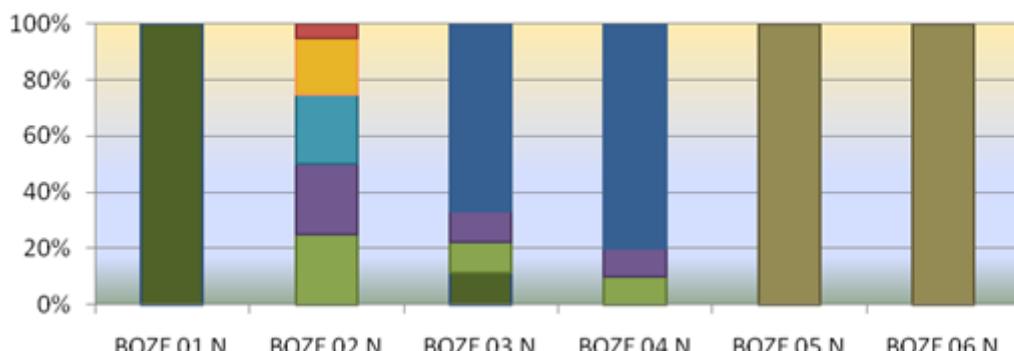
Right Bank Land Use on Sourdough Creek

- Rural Res.
- Urban
- Residential
- Golf
- Dry Crops
- Irr. Crops
- Dry Pasture
- Irr. Pasture
- Forest
