**FISHER and KOOTENAI TPA BIOLOGICAL SAMPLING 2011:
MACROINVERTEBRATE AND PERIPHYTON RESULTS**

December 2011

1.0 Study Objective and Area

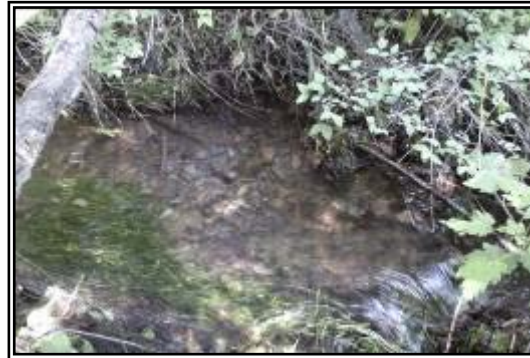
3.1.1 RAVN06-01

This alder-dominated riparian had several weed species present. The reach showed signs of being in a state of natural recovery following surrounding land use impacts. Patches of reed canary grass were dense and tall in places. Dense thickets of alder break up weeds. Macrophytes were observed in more abundance where larger canopy openings were observed. The reach was found impaired for periphyton. An impairment summary is provided in **Table 4** and summary results of the Fish Cover/Other form are presented in **Table 5**.

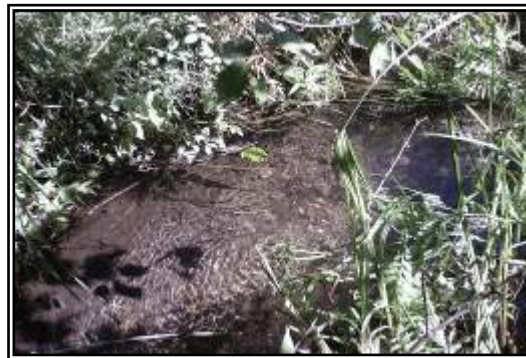
3.1.2 RAVN07-01

This reach showed a relatively healthy riparian surrounded by weeds. The stream had easy accesses to its floodplain, where vegetation varied between alder and hawthorne to aspen and canary reed grass. This reach was found impaired for periphyton. An impairment summary is provided in **Table 6** and summary results of the Fish Cover/Other form are presented in **Table 7**.

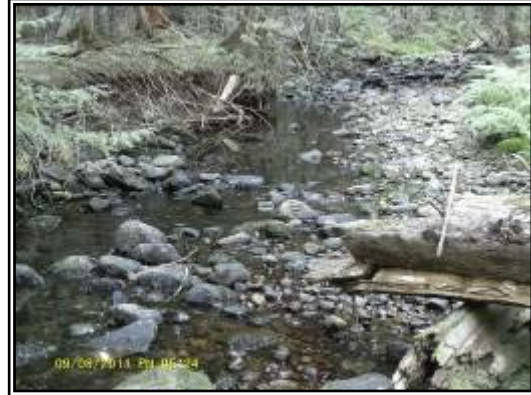
3.2.1 BRST04-02

Moss dominates the stream bottom in this cedar forest. The channel is slightly entrenched with pools and side channels common. Periphyton was found to be unimpaired in this reach, while results for macroinvertebrates were found to be beyond the scope of the O/E model. This means the reach is either a reference reach or nutrient impaired and would require field evaluation by DEQ personnel. An impairment summary is provided in **Table 8** and summary results of the Fish Cover/Other form are presented in **Table 9**.

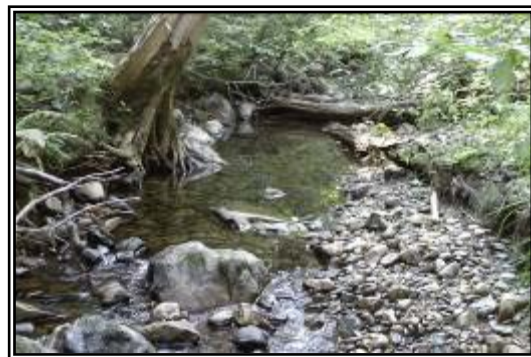
3.2.2 BRST04-04

This stream lies in a Cedar-dominated alluvial fan system, which sub-surfaces and braids often. The narrow and shallow stream made macrophyte sampling tricky, as most areas deep enough for a net were in “pocket water” almost trapped among large cobbles. Replicate samples were taken here. Both periphyton sample results showed unimpaired and both macroinvertebrate samples scores outside the scope of the O/E model. Further evaluation will be needed to determine if these scores mean the stream is in reference condition or show excess nutrients. An impairment summary is provided in **Table 10** and summary results of the Fish Cover/Other form are presented in **Table 11**.

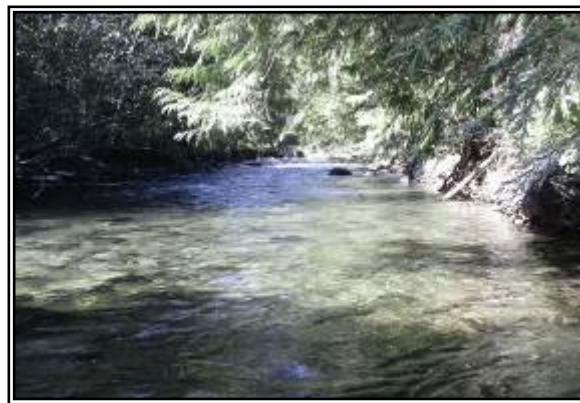
3. 1.3 LAKE 02-01

This stream reach is confined in a steep valley with cedar and alder riparian vegetation in a natural setting. Light brown filamentous algae was seen on many rocks. Microalgae was rare and some moss was seen on the sides of the channel. Periphyton readings showed unimpaired while macroinvertebrate scores were outside the scope of the model. Additional assessment by DEQ personnel will be needed to determine whether this means if the reach has a nutrient impairment or is a reference reach. An impairment summary is provided in **Table 12** and summary results of the Fish Cover/Other form are presented in **Table 13**.

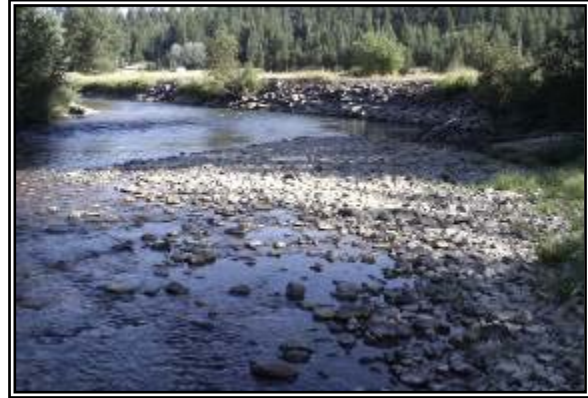
3. 1.4 LAKE03-03

Rocks on the stream bottom here are not slick and have minimal microalgae, concentrated mostly on the sides of streams in more slack water, and in side channels. The stream is entrenched on one side from the road. The stream appears over-widened and is heavily rip-rapped on outside bends. Periphyton concentrations varied dramatically depending on width and flow. A large island at F created small side channels coated in light brown filamentous algae. Results showed unimpaired for both periphyton and macroinvertebrates. An impairment summary is provided in **Table 14** and summary results of the Fish Cover/Other form are presented in **Table 15**.

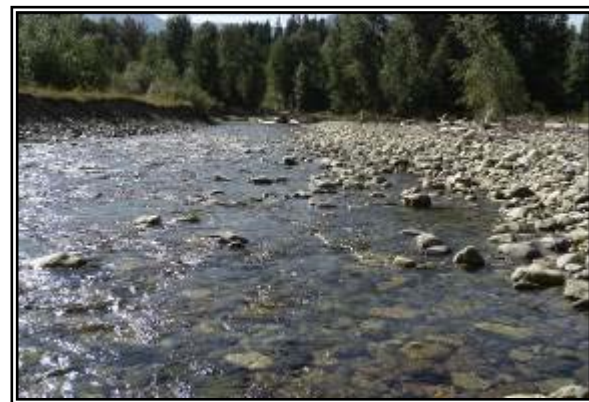
3. 1.5 LIBY09-03

This reach is on a cobble streambed with very slick rocks. Many were green in appearance but no algae could be scraped from them. Algae was rated a 1 throughout according to explanations in the methods section. The stream is mostly shallow and riffle dominated. Macroinvertebrate impairment was determined to be moderate while periphyton appeared unimpaired. An impairment summary is provided in **Table 16** and summary results of the Fish Cover/Other form are presented in **Table 17**.

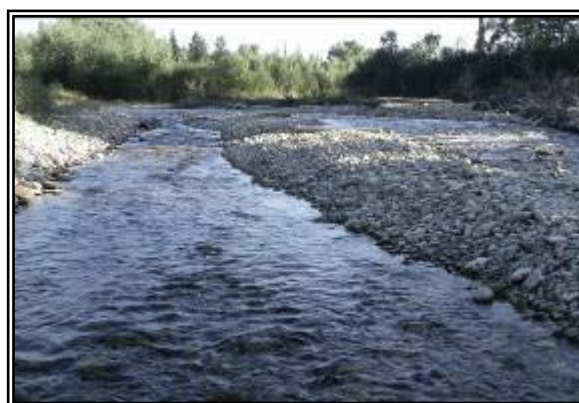
3.1.6 LIBY09-05

This site is similar to the upstream site except the slickness of rocks is less here. No microalgae were seen but rocks remain slippery. Several side channels and braids were formed. There were minimal signs of microalgae or filamentous algae. In several reaches filamentous algae were only seen in side channels and slack water. An

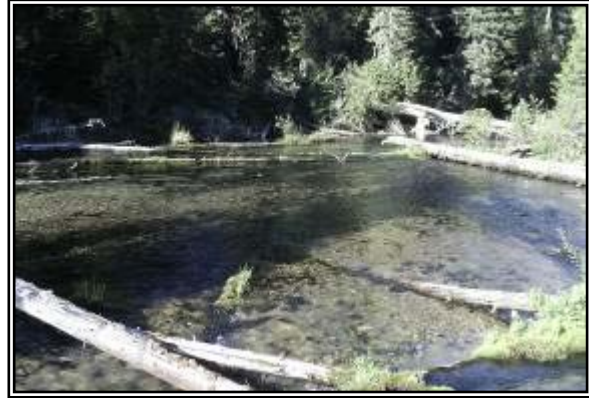
3.2.7 Fairway Creek

This stream is in a cedar-bottomed alluvial fan, unconfined and with multiple braids. There was much downed wood in the cold stream with moss abundant. Both periphyton and macroinvertebrates were shown to be unimpaired. An impairment summary is provided in **Table 20** and summary results of the Fish Cover/Other form are presented in **Table 21**.

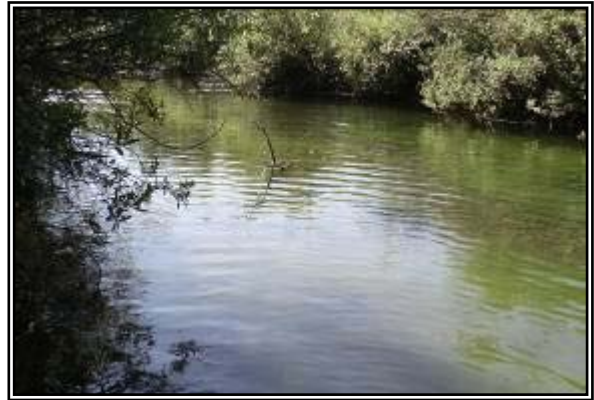
3.2.9 WOLF11-03

The downstream half of this reach is in a confined, straight reach parallel to and constrained by the road. The upstream end meanders away from the road and heavy rip-rap near F. Micro and filamentous algae coat most rocks leaving the stream with a brownish/green appearance. The dominant algae in the stream is mature or decaying. Some green algae and moss were seen but small numbers in comparison to more decadent periphyton. Algae cover was noticeably different as the stream approaches the road and straightens at G. Coverage became less thick on rocks as flows increased, but only in this G reach. Both macroinvertebrates and periphyton were unimpaired from results of analysis. An impairment summary is provided in **Table 24** and summary results of the Fish Cover/Other form are presented in **Table 25**.

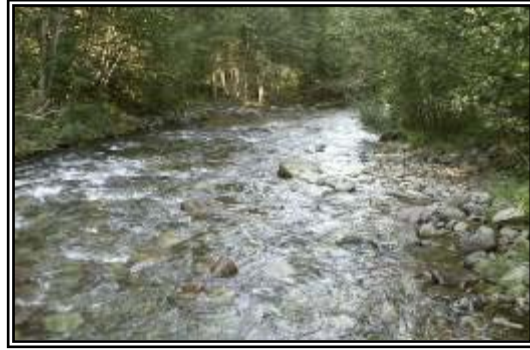
QUTZ 10-01

This reach is constrained on one side by hillslopes. Channel substrate and periphyton communities appeared consistent throughout the reach. No impairment was found for periphyton, while macroinvertebrates were found to be moderately impaired. An impairment summary is provided in **Table 26** and summary results of the Fish Cover/Other form are presented in **Table 27**.

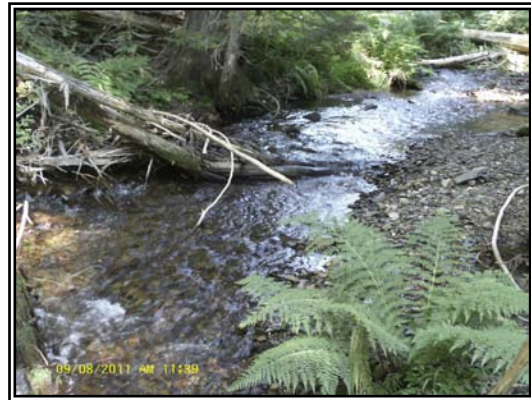
QRTZ 03-01

This reach is in a tight valley. The channel is confined but in a healthy condition in a cedar bottom. Small amount of filamentous algae noted in each transect. Moss was common. Replicate samples were taken here. Both samples for periphyton were unimpaired. The original sample for macroinvertebrates was determined to be beyond the scope of the O/E model. The replicate sample showed no impairment. An impairment summary is provided in **Table 28** and summary results of the Fish Cover/Other form are presented in **Table 29**.
