Watershed Characterization - Final

Haskill Creek TMDL Planning Area

RIVER DESIGN GROUP, INC.
5098 HIGHWAY 93 SOUTH
WHITEFISH, MT 59937

April 2007

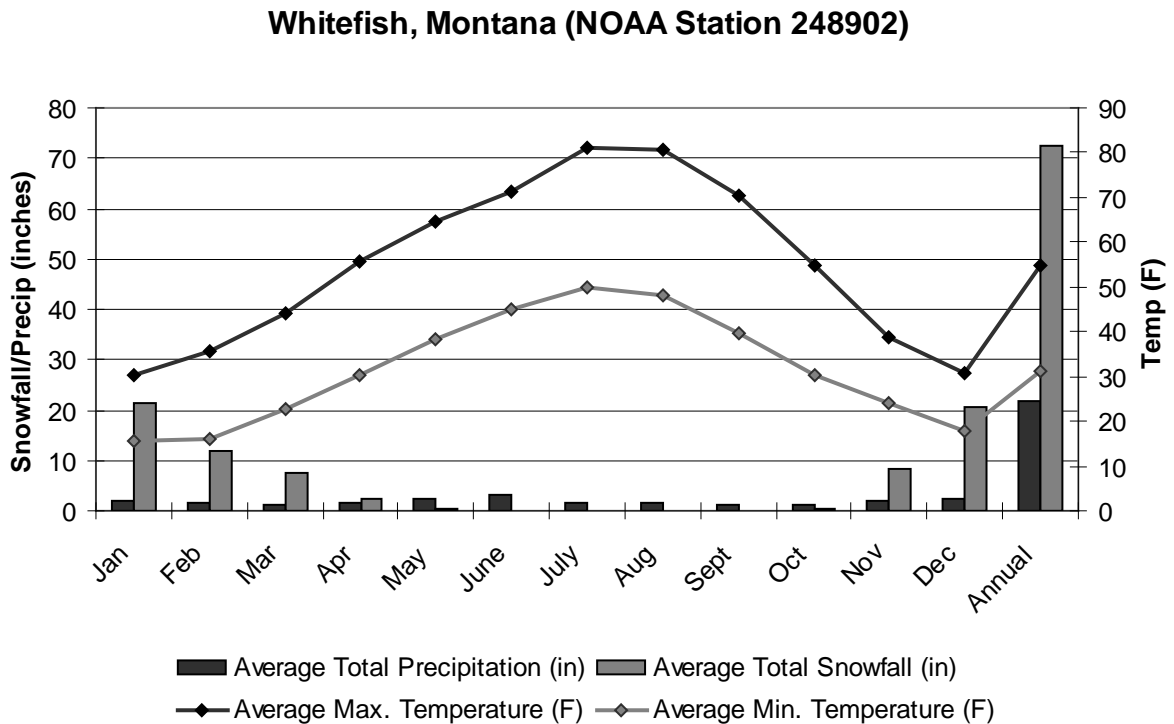
Figure 1-1. Climate data for Whitefish, Montana (Station 248902).

There are no NOAA weather stations within the Haskill TPA, however the closest NOAA station is located in the City of Whitefish, adjacent to Haskill Creek (Station 248902) (Figure 1-1). Although average annual precipitation is 22.0 inches in Whitefish, this value reflects lower, valley bottom elevations. This should be considered the lower range of precipitation within the TPA. Conversely, in headwater areas and at Big Mountain summit average precipitation can exceed 70-80 inches annually (USDA 1995). Approximately 60% of the mean annual precipitation falls as snow and forms the snowpack between November and April (on average).

Average maximum temperature at the weather station in Whitefish ranges between 71° and 81°F in summer. Average minimum temperatures range between 16° and 18° F in winter. Milder temperatures can be assumed to prevail with increasing elevation.

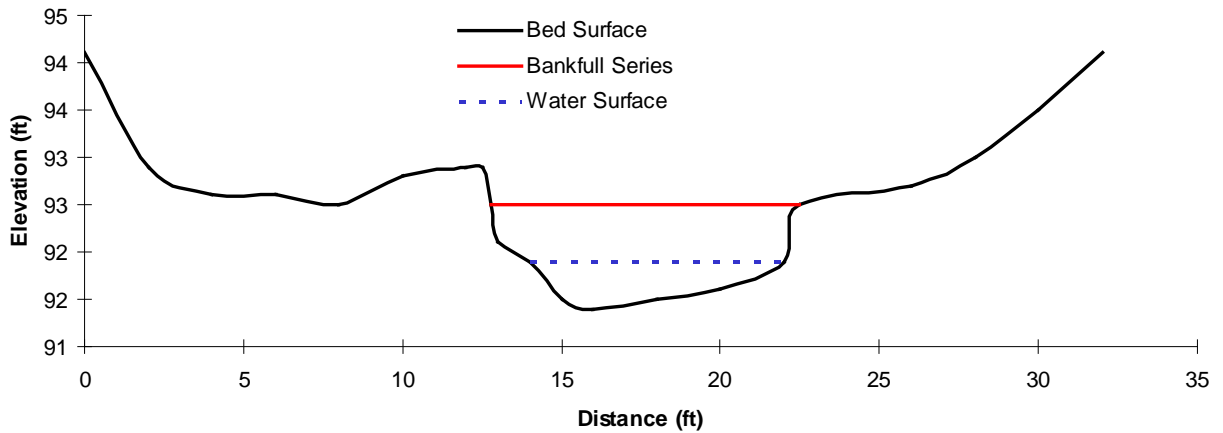
Figure 1-2. Typical channel cross-section in Reach 1, First Creek.

The headwater channels of Reach 1, including First Creek, Second Creek, and Third Creek, characterized by step-pool bedform features, were generally steep and confined within relatively narrow, glacial scoured valley types (Table 1-5 and Figure 1-2). These channel types displayed erosional processes that varied from very low and stable to highly erodible, depending on the degree of direct manipulation by management activities and inherent watershed characteristics (i.e. soils types, landform slopes). First Creek, in the vicinity of Big Ravine (USFS property), is an example where direct channel modification (i.e. channel relocation and straightening) has promoted channel instability, increasing sediment supply to First Creek. Second Creek and Third Creek are largely undeveloped, and as a result, exhibit stable channel conditions. Natural sediment sources consisting of shallow soils overlying steeply dipping bedrock were inventoried in the upper headwaters of these drainages, notably in the Third Creek drainage.

BF Width (ft)	Mean D (ft)	Max D (ft)	W/D Ratio	XS Area (ft ²)	Slope (%)	FP Width (ft)	Entrenchment Ratio
8.15	0.95	1.45	8.85	7.78	10.7	16.0	1.90

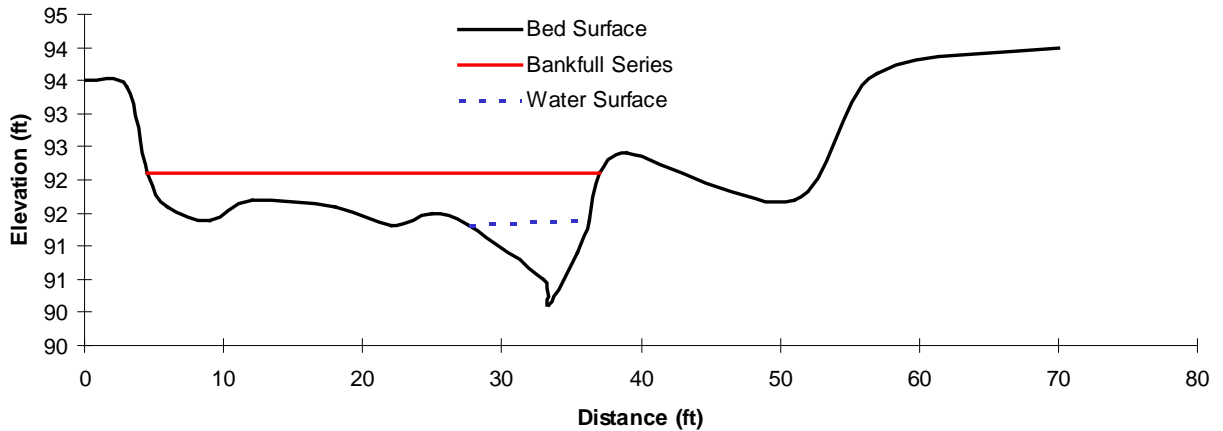
Figure 1-4. Typical channel cross-section in Reach Five, Haskill Creek.

Downstream of Haskill Basin Road, Reaches 4 and 5 in Haskill Creek transition to a low-gradient channel type as the valley broadens (Table 1-7 and Figure 1-4). This section of

the drainage is formed in broad valleys with gentle, down-valley elevation relief. Channel modifications for agriculture have altered the channel form and function. Changes in vegetative cover types, channel straightening and relocation, and direct streambank modifications have resulted in impaired stream conditions and increased sediment supply to Haskill Creek. Historically, and prior to agricultural conversion, these channel types likely displayed very stable plan forms within a broad, accessible floodplain dominated by wetland and riparian plant species. Vegetation likely played an integral role in maintaining channel stability due to the fine-grained nature of the underlying soils. Spatial and temporal variability in channel stability was very likely, however, due to the influence of beaver activity and other natural processes including flooding. This is especially true within reach 6, downstream from Monegan Road, where a low gradient, E-type channel meanders through a well-vegetated floodplain corridor. Evidence of beaver activity and flooding is prevalent.

BF Width (ft)	Mean D (ft)	Max D (ft)	W/D Ratio	XS Area (ft ²)	Slope (%)	FP Width (ft)	Entrenchment Ratio
64.3	1.19	2.60	51.2	89.3	0.90	77.0	1.33
